## WAIUAU TOA/CLARENCE RIVER BLACK-FRONTED TERN RESTORATION PROJECT: MARCH 2022 ISLAND ENHANCEMENT WORK

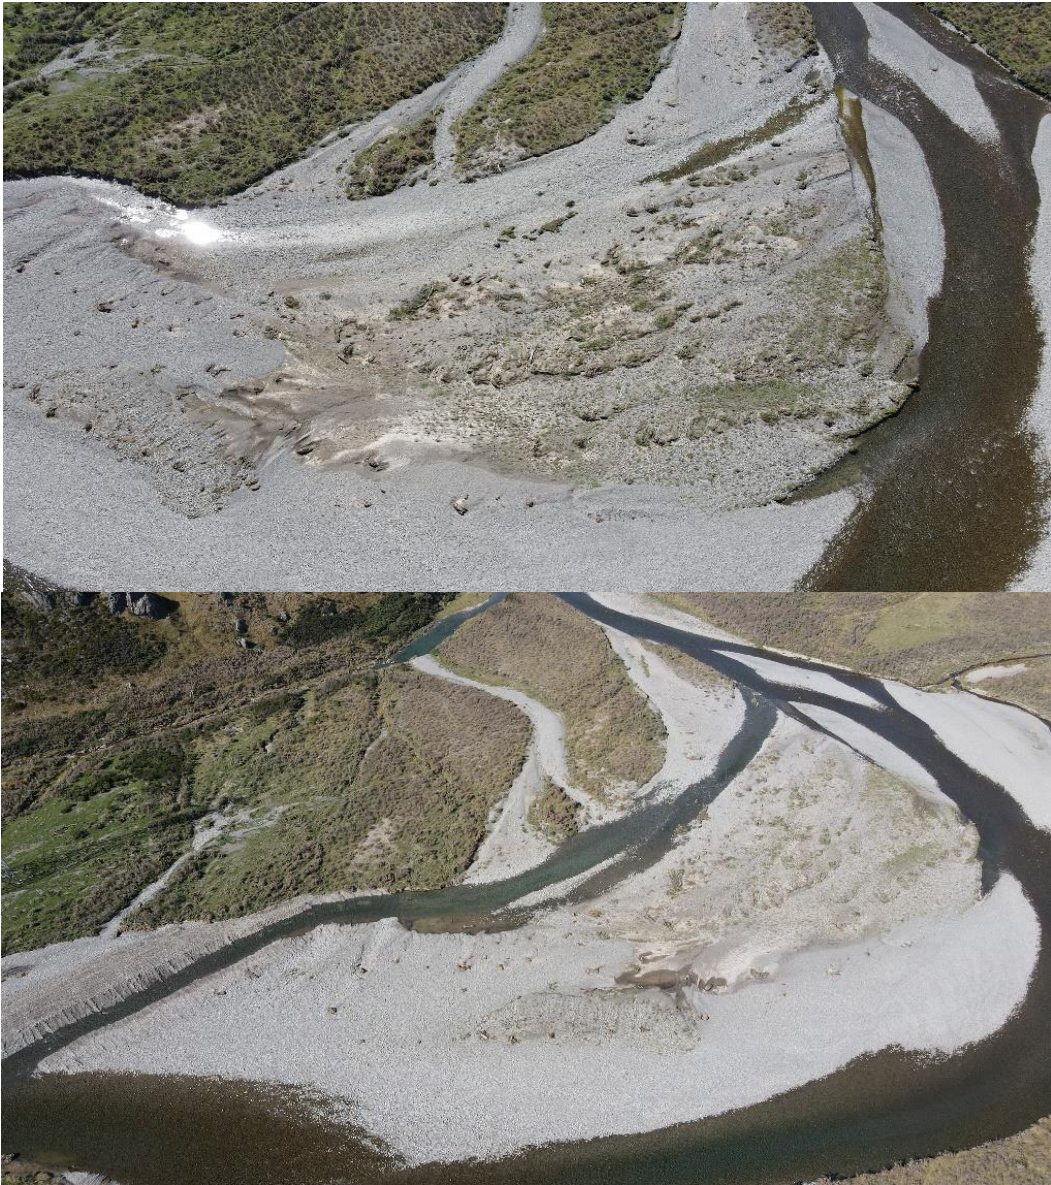
- Channel was cleared and opened up to allow river flow through previously dried up channel (Figures 2 and 3).
- Material from the channel was used to raise the height of the island slightly and stabilise the bank on the opposite side.
- Channel was then opened from the top of the island.
- Construction mostly occurred in dry areas until channel was opened which required no fish recovery.

**Figure 2.** Before (upper) and after (lower) images of Upper Swimming Hole. Channel cut through river gravels and opened up allowing river flow to surround the island.

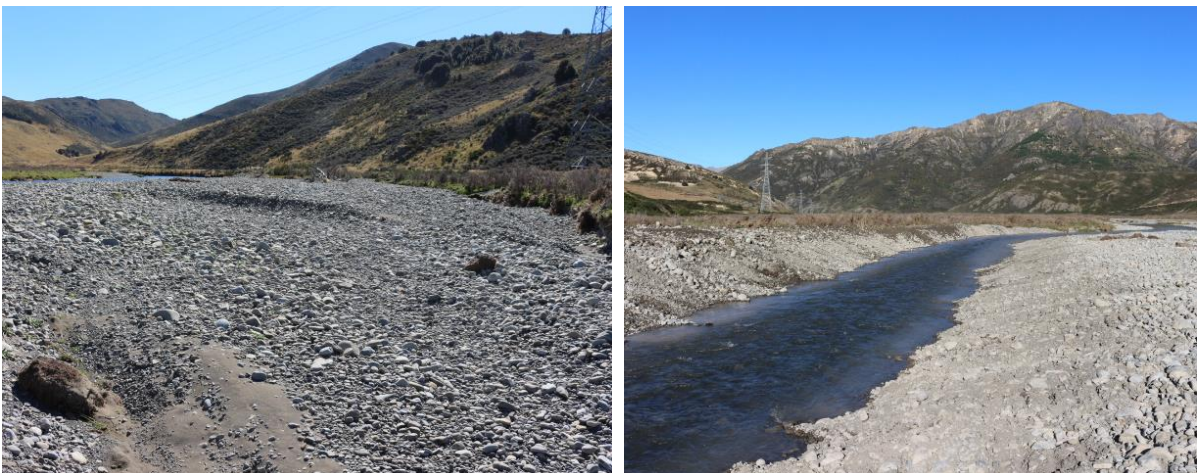
**Figure 3.** Before (left) and after (right) shots of river gravels blocking channel (left) and channel after being cleared by bulldozer (right).

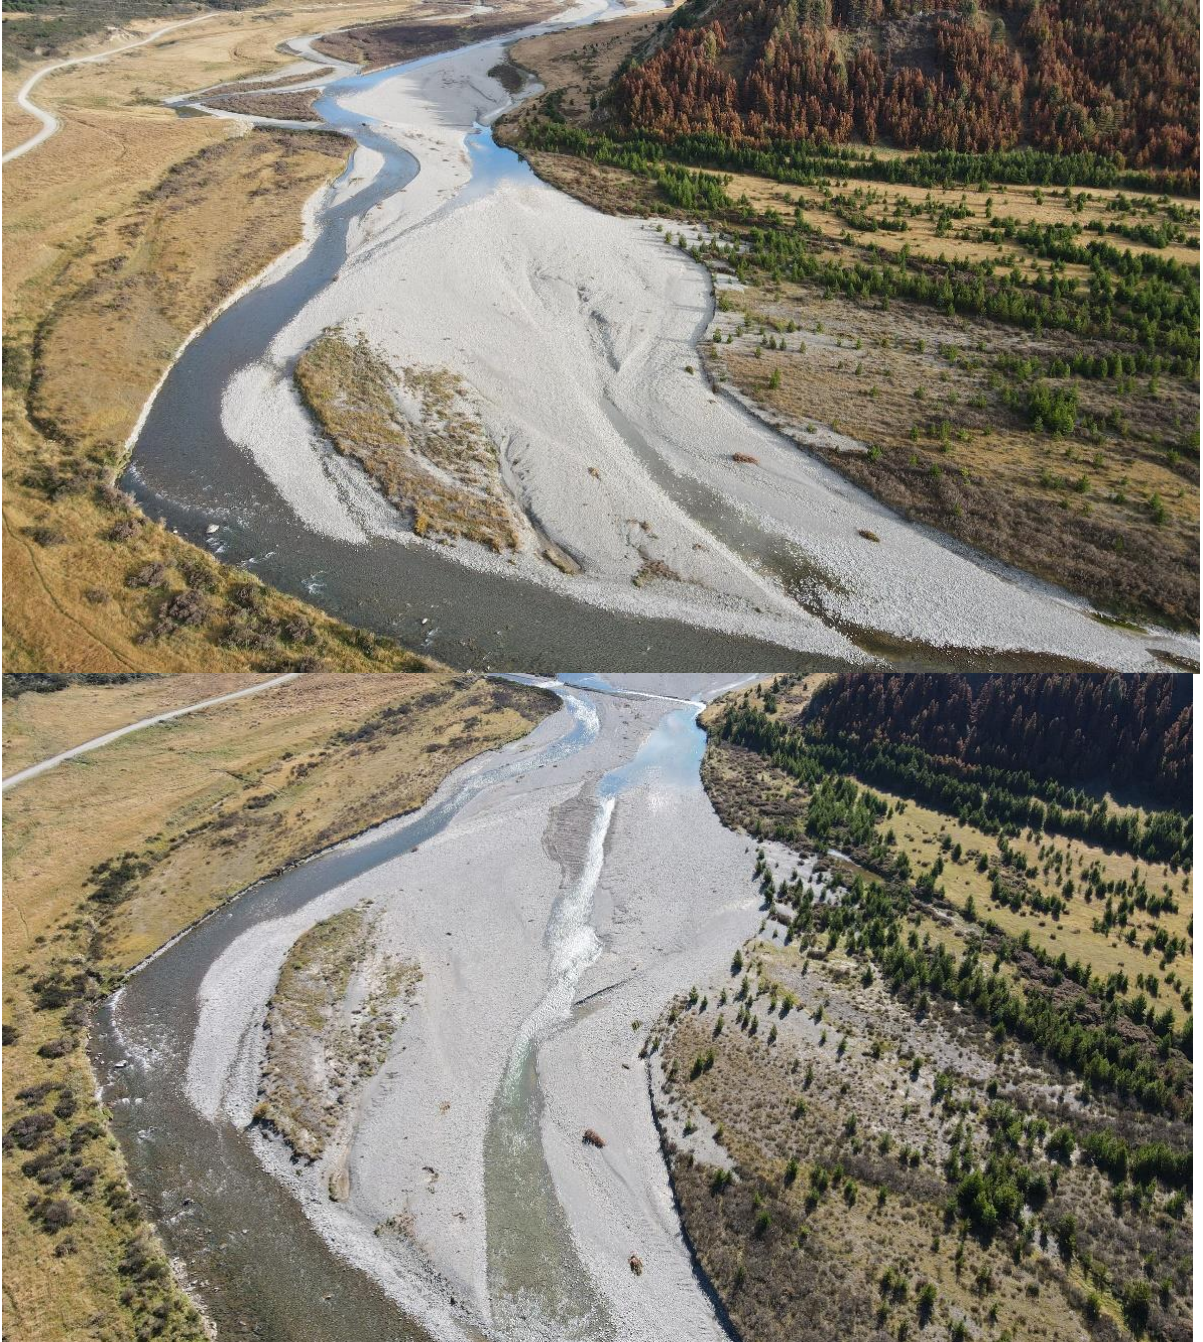
- Dry, filled in pre-existing channel was cleared and widened.
- Material from channel was pushed onto island to raise height.
- River channel was diverted further upstream to allow river flow to travel around true left side again.
- No fish recovery was required.

**Figure 4.** Before (upper) and after (lower) images of Cow Island. River flow was diverted upstream to allow river flow down true left side and along newly cleared and widened channel (true left side of Cow Island).

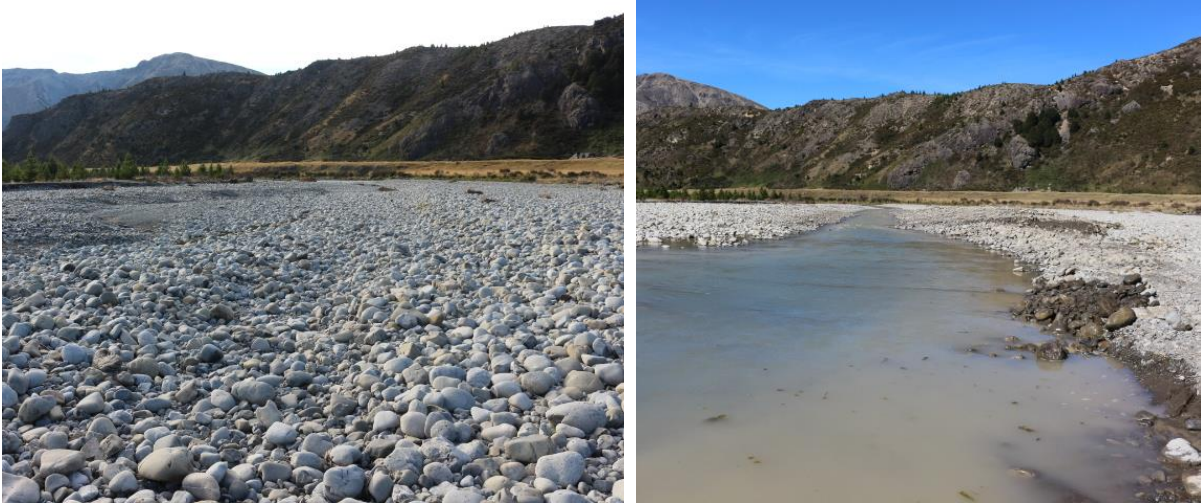
**Figure 5.** Before (left) and after (right) images of dried up channel along the true left side of Cow Island (left) and bulldozer enhancement works to reopen and clear channel (right).

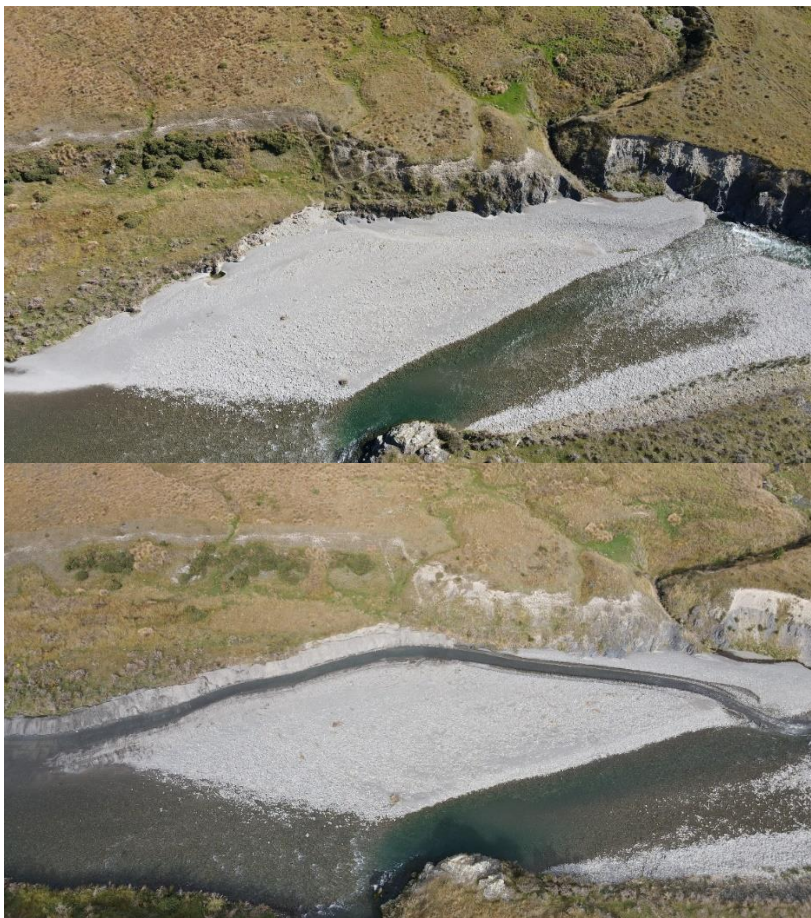
- Large natural channel dried up around true left side of “island” was deepened, widened, and opened to allow water flow to surround the island.
- No fish recovery was required.

**Figure 6.** Before (upper) and after (lower) images of island enhancement work on Eddy's Inlet.

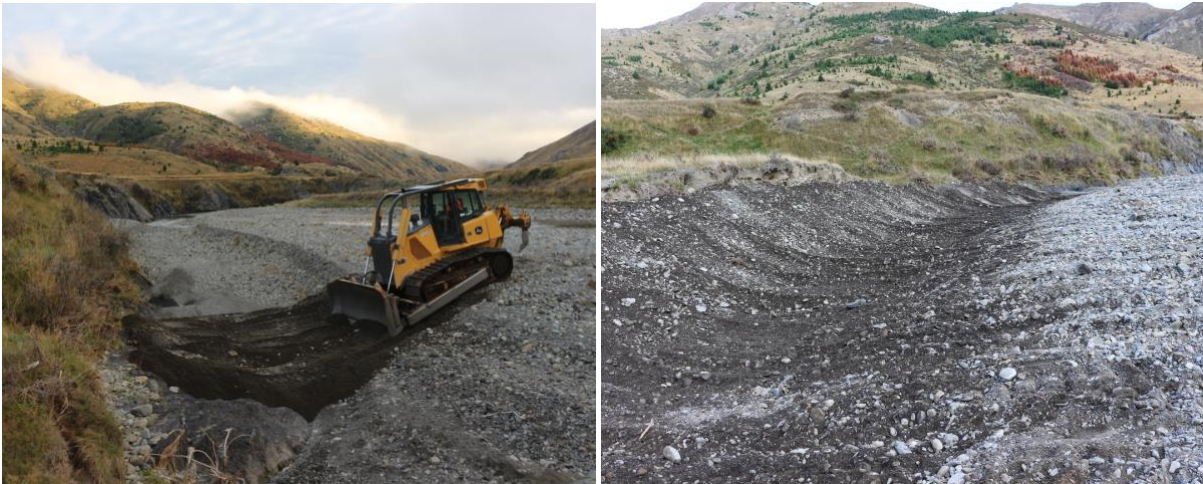
**Figure 7.** Before (left) and after (right) images of the bulldozer works to deepen and clear channel around the true left side of Eddy's Inlet.

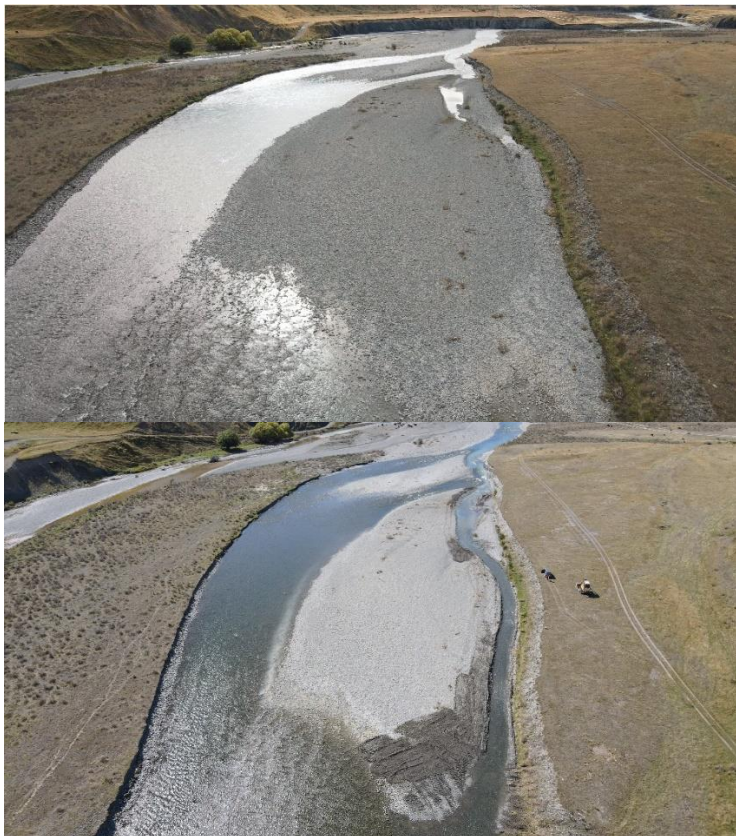
- Channel around true right side of "island" to be cleared, widened and deepened to allow river flow around island.
- River was directed down true right side of island.
- Gravels from the channel were pushed onto island to slightly raise the island height.
- No fish recovery was required.

**Figure 8.** Before (upper) and after (lower) images of island enhancement work on upper Bush Gully Island.

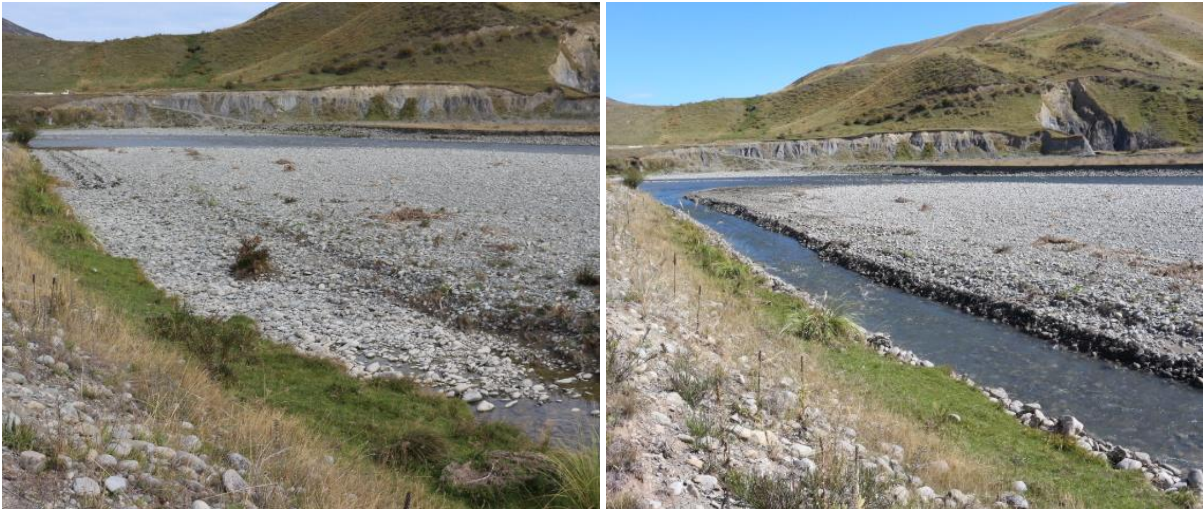
**Figure 9.** Before (left) and after (right) images of clearing, deepening and opening the river channel down the true right side of upper Bush Gully.

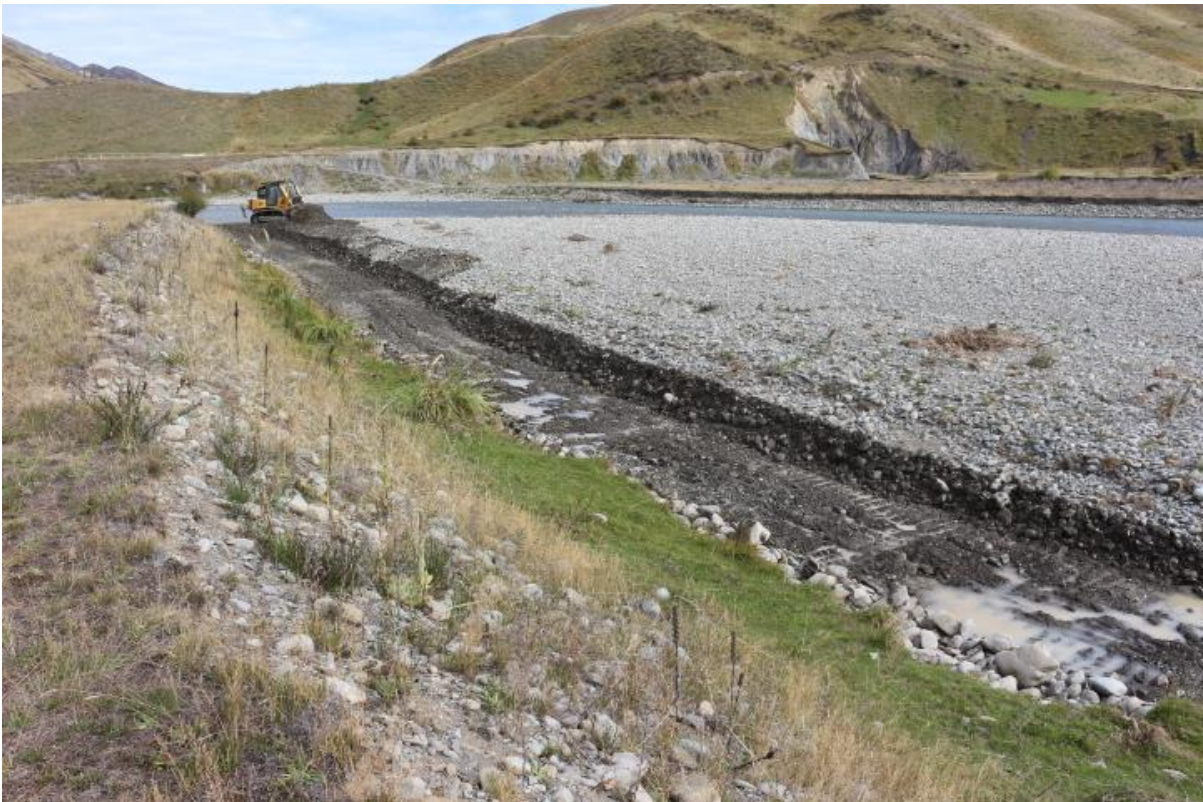
**Figure 10.** Bulldozer working to open up the newly cleared and deepened channel at upper Bush Gully.

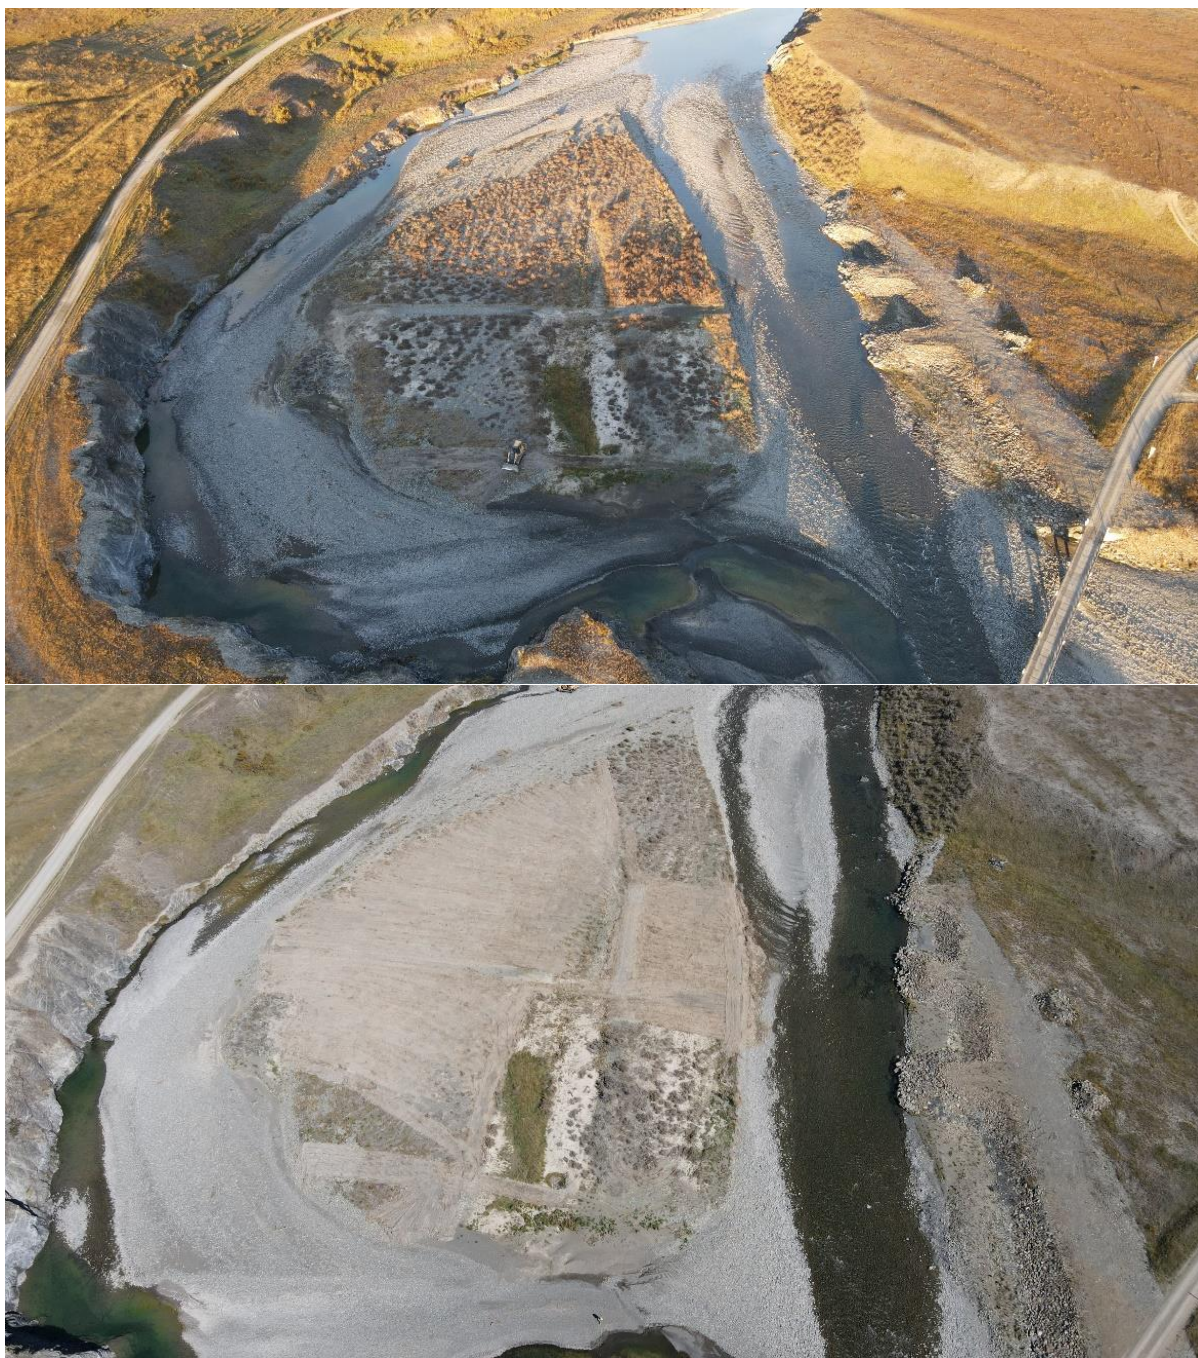
- Island was mostly cleared of broom and other vegetation.
- Small pockets of vegetation was left at edges of the island to provide a level of shade.
- Natural riverbed vegetation present on the island edges was left untouched.
- No fish recovery was required.

**Figure 11.** Before (upper) and after (lower) images of bulldozer weed clearance on Bridge Island.

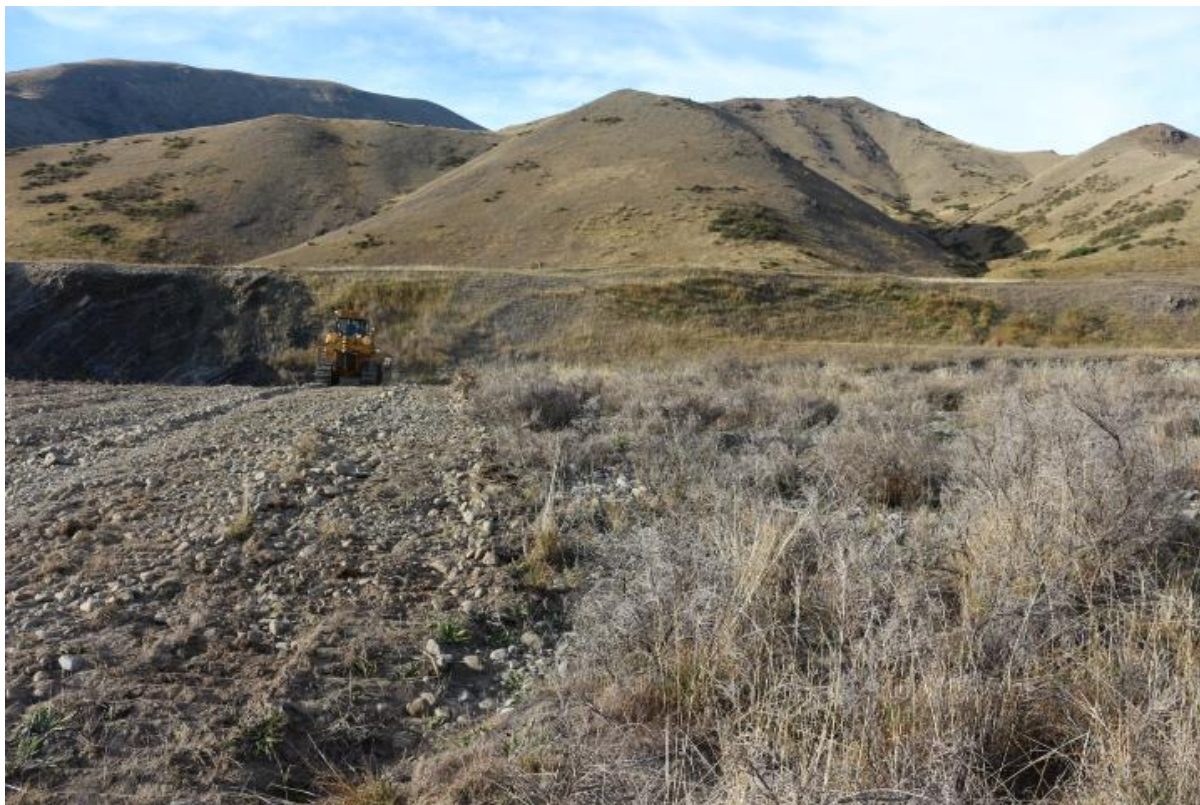
**Figure 12.** Bulldozer clearing broom and other vegetation to reveal river gravels underneath suitable for black-fronted tern nesting on Bridge Island.
