The Plight of the Foothills-fed Canterbury Braided Rivers

Ashley River, July 2020 - not a natural landscape

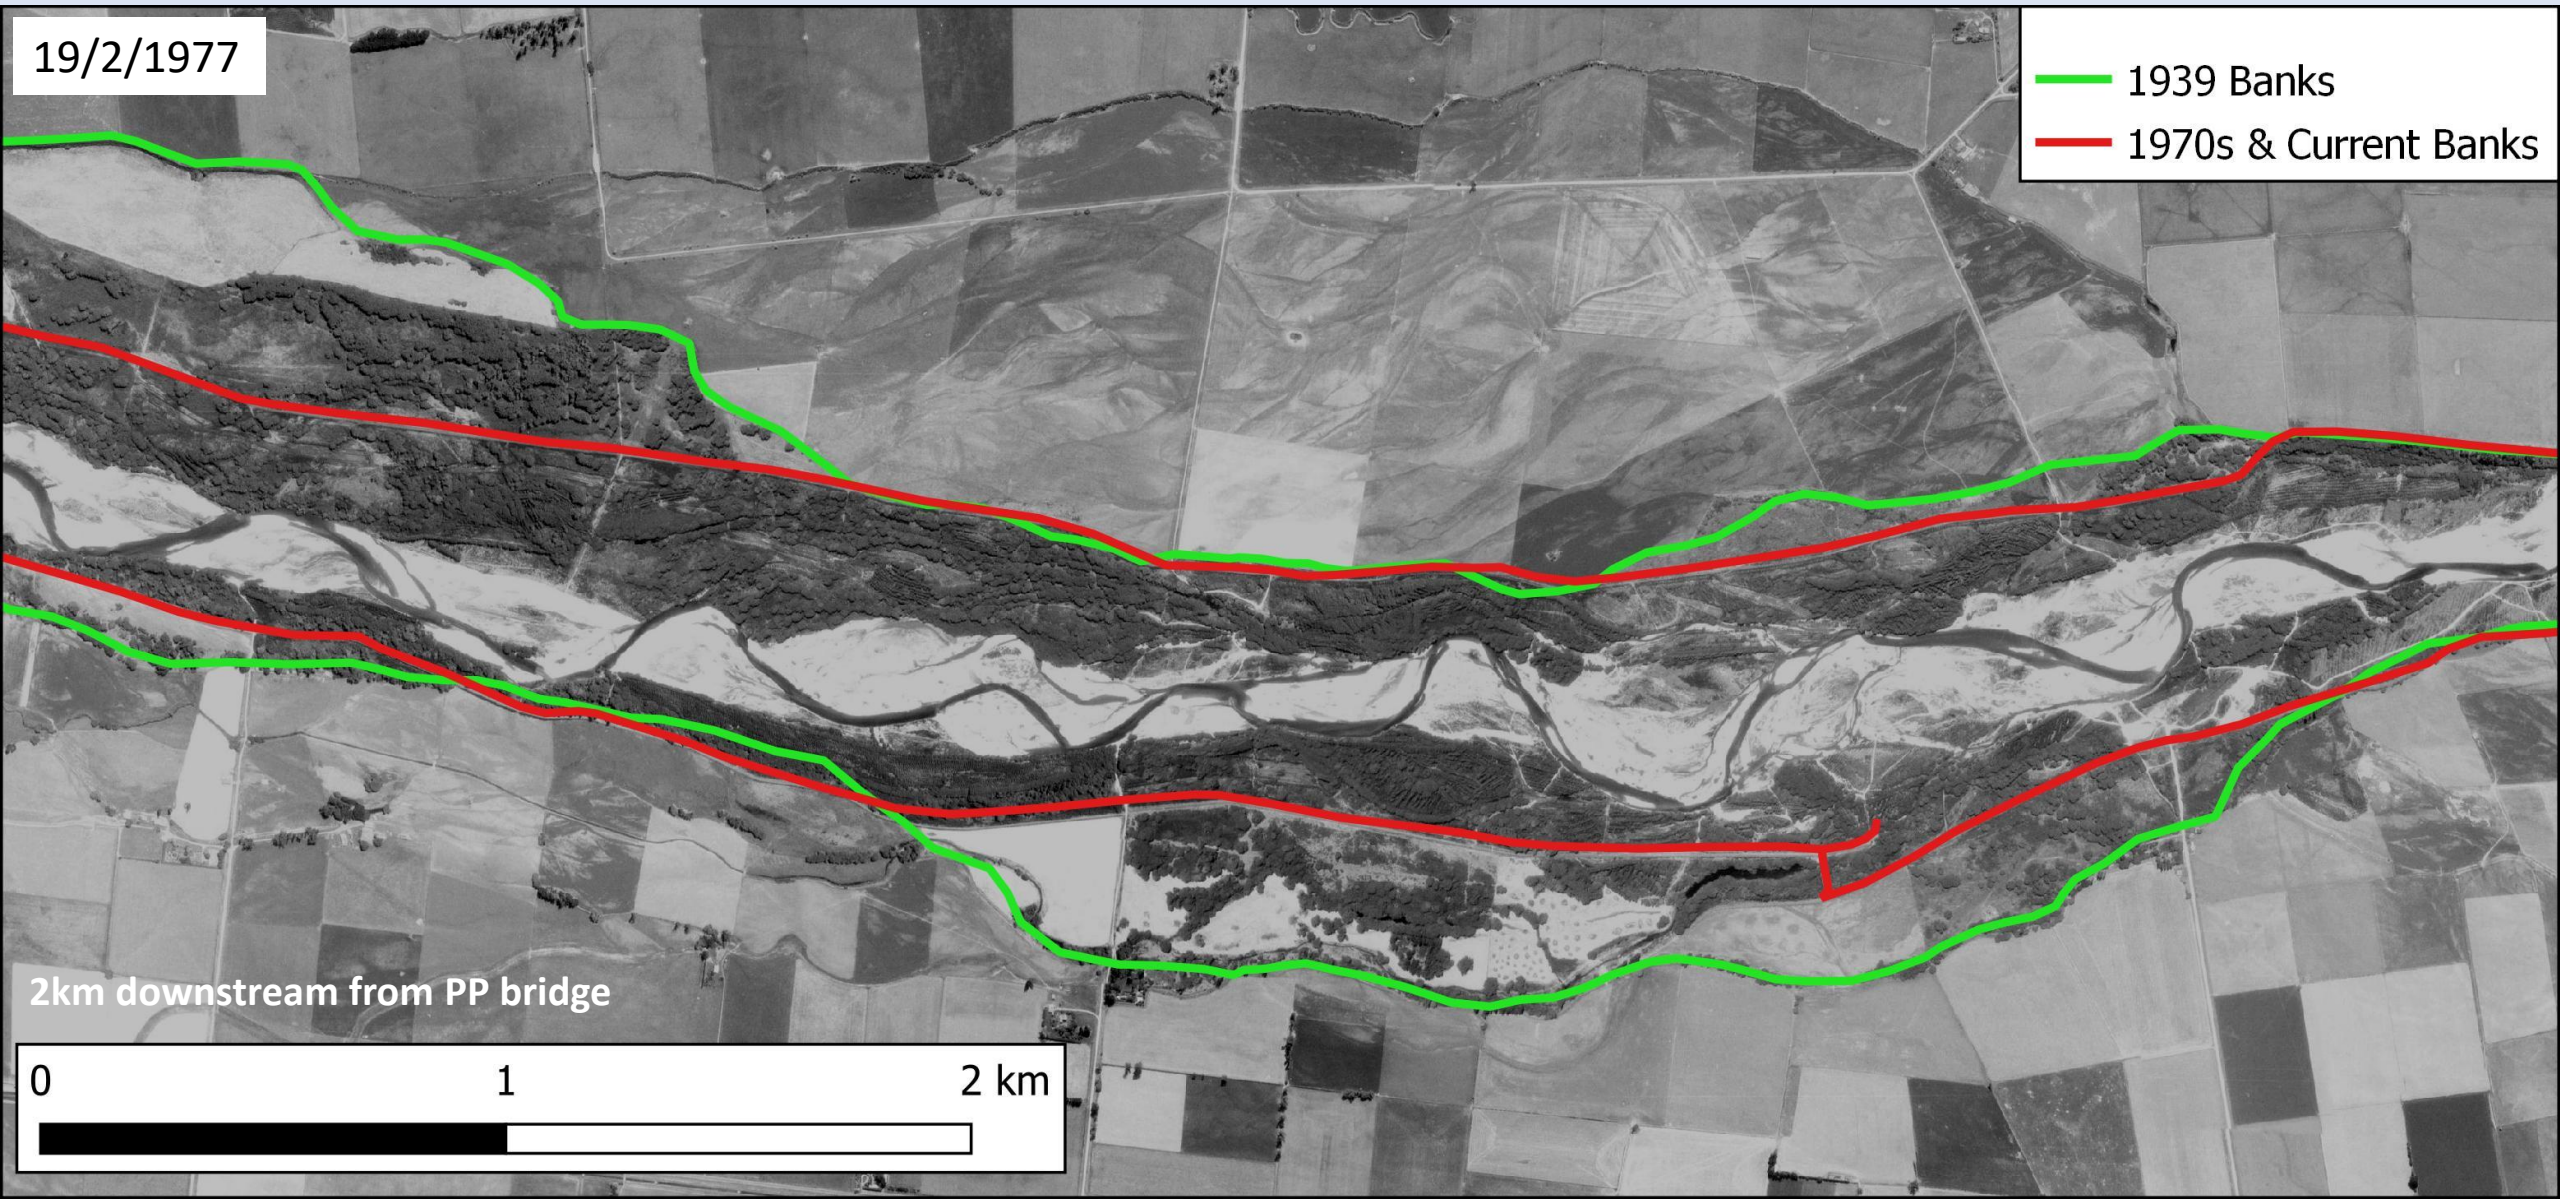
1977

New stopbanks and tree planting in early 1970s. No longer a braided river - an incised single channel. Bird numbers likely plummeted, remaining ones would have been more susceptible to predation

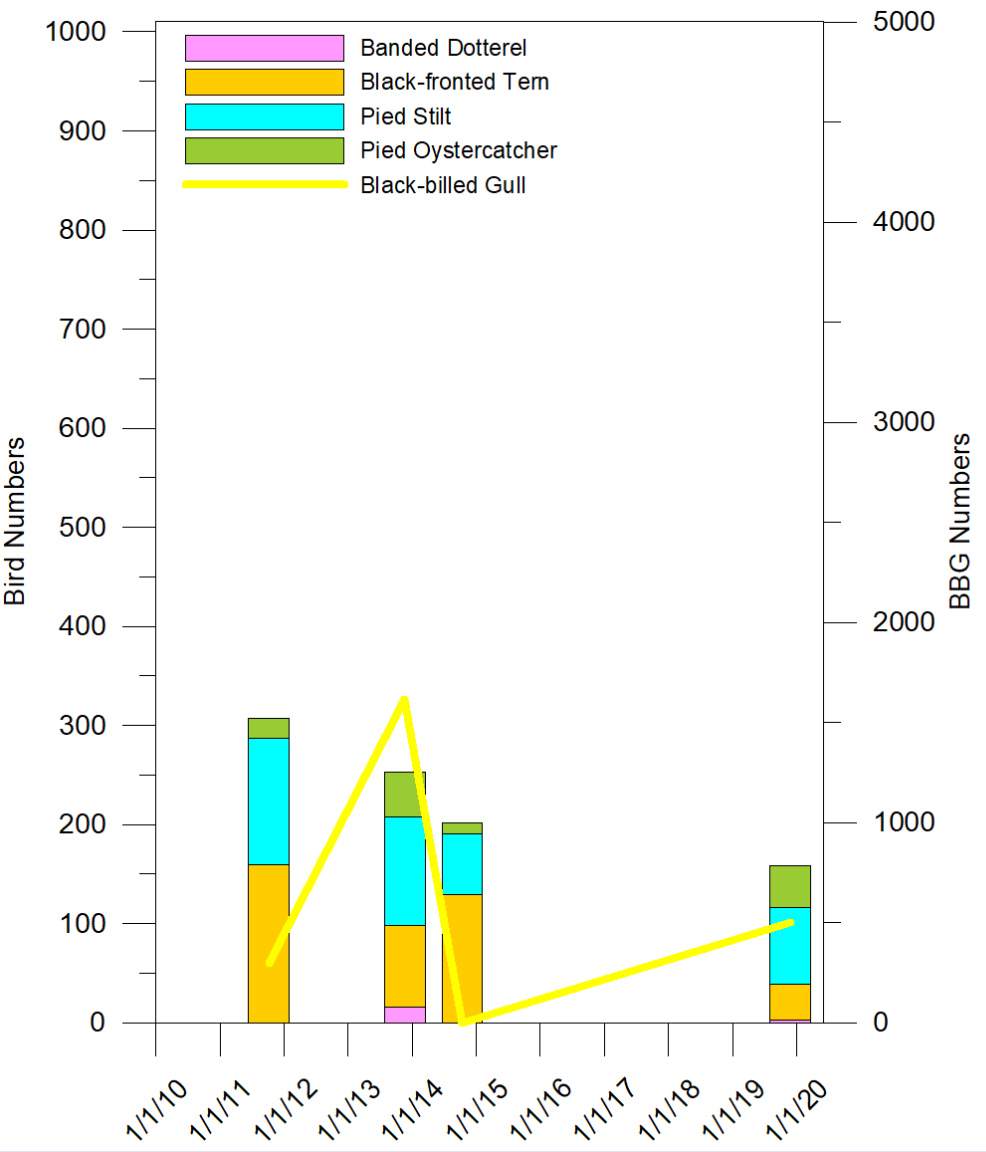
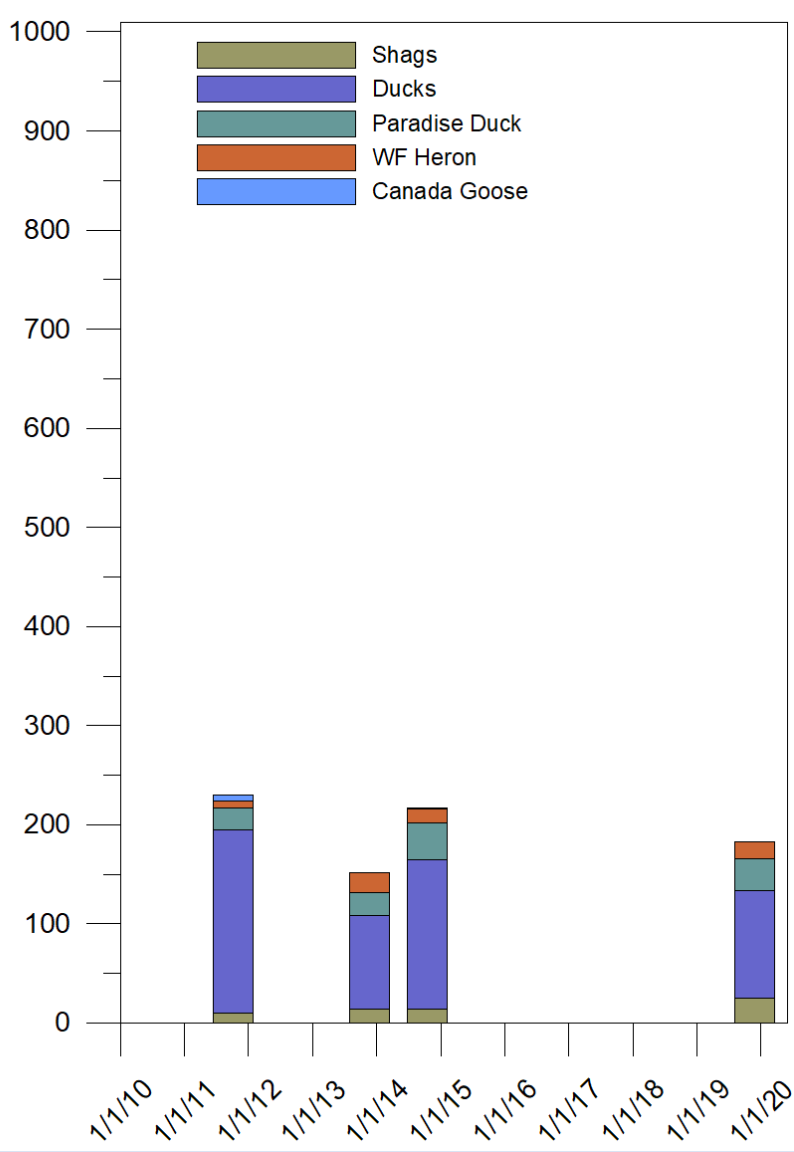
Opihi Annual Bird Counts – Raincliff Bridge to Lagoon – 32 Kilometres

Good BBG numbers, terrible numbers for other braided river birds

“River birds” prefer single channel deep tree-lined rivers. If they nest on the rivers, it is in vegetation as opposed to bare gravel. In a braided river braided river birds should grossly outnumber “river” birds. In 2014 and 2019 river birds outnumber braided river birds.

Average Braided River Birds/River Birds = 1.2

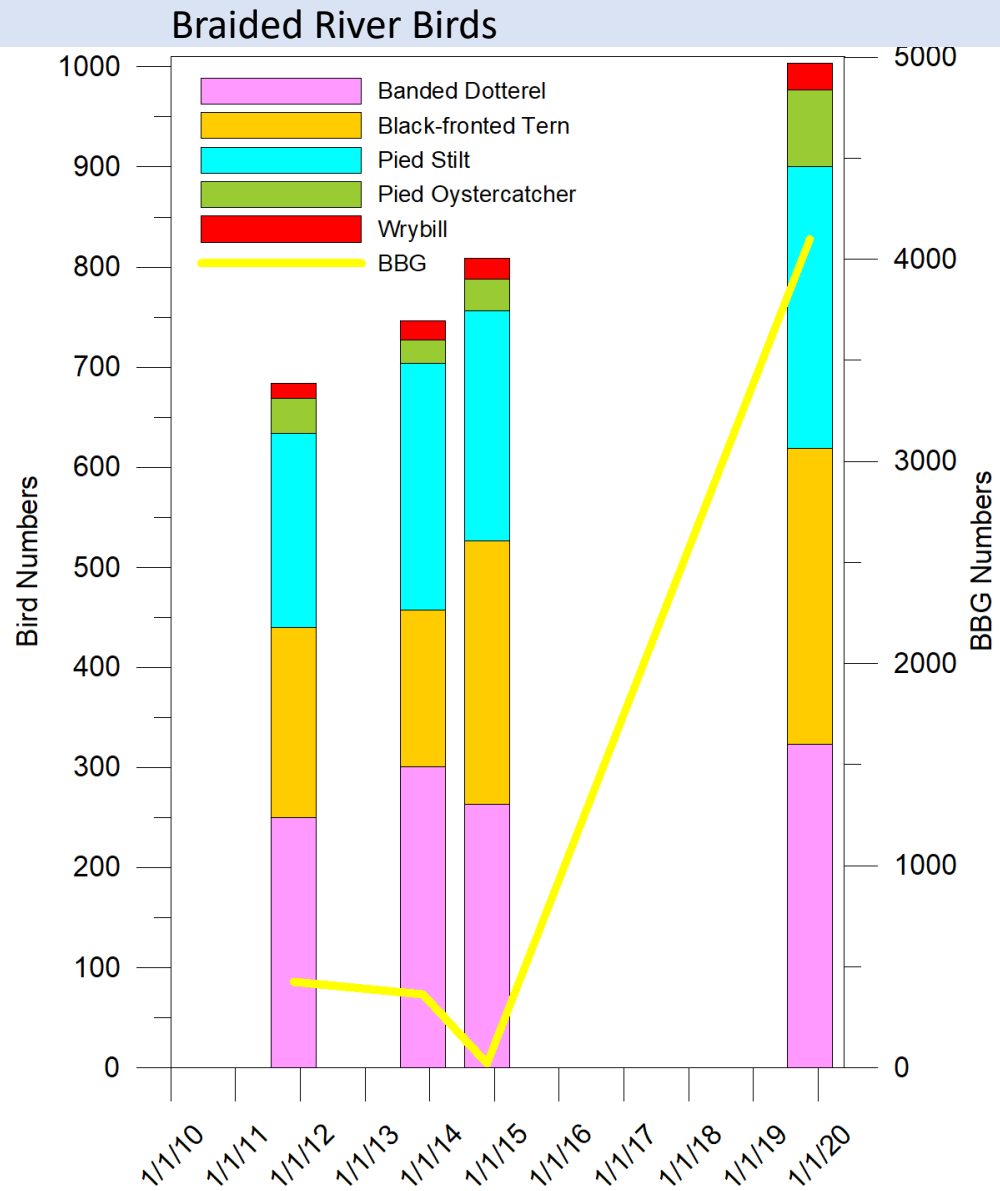
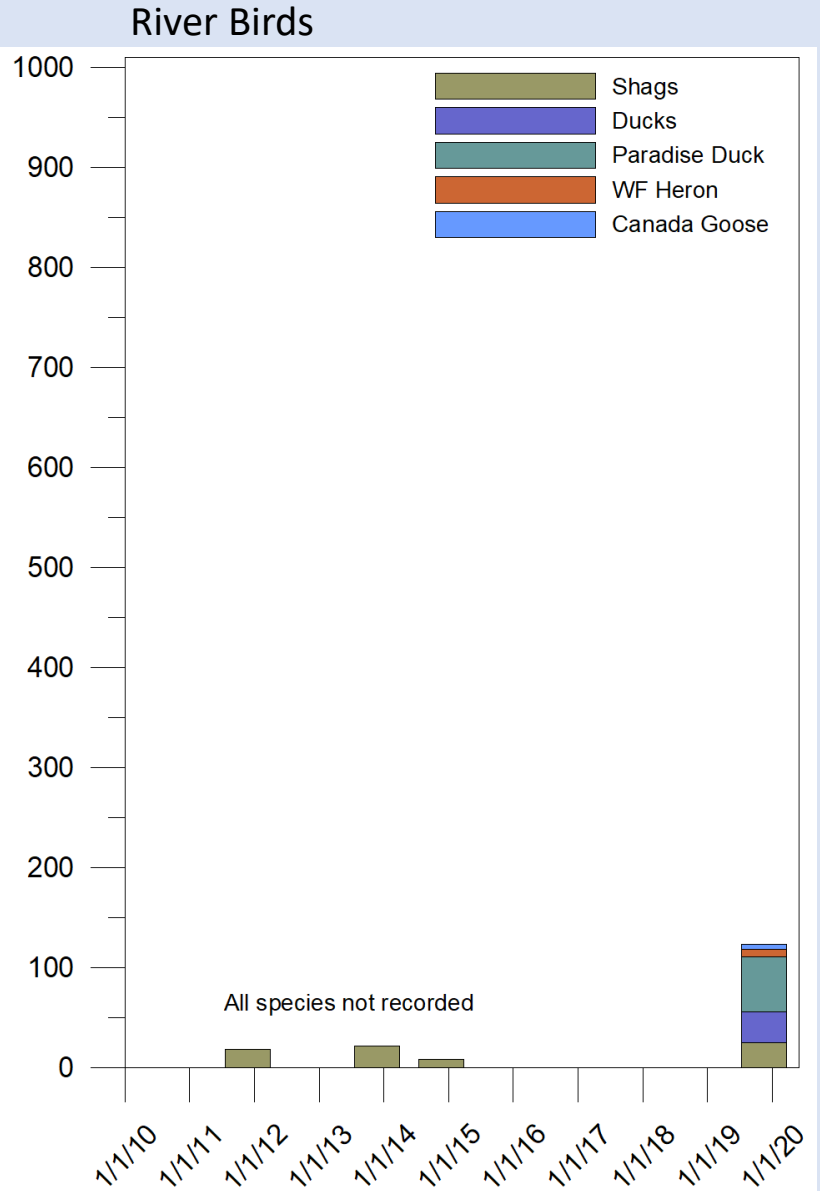
Ashley Annual Bird Counts – Okuku Junction to SH1 – **19 Kilometres**. Same scale

Average Braided River
Birds/River Birds for
2018 - 2020 = 6.3

Opihi – 1.2

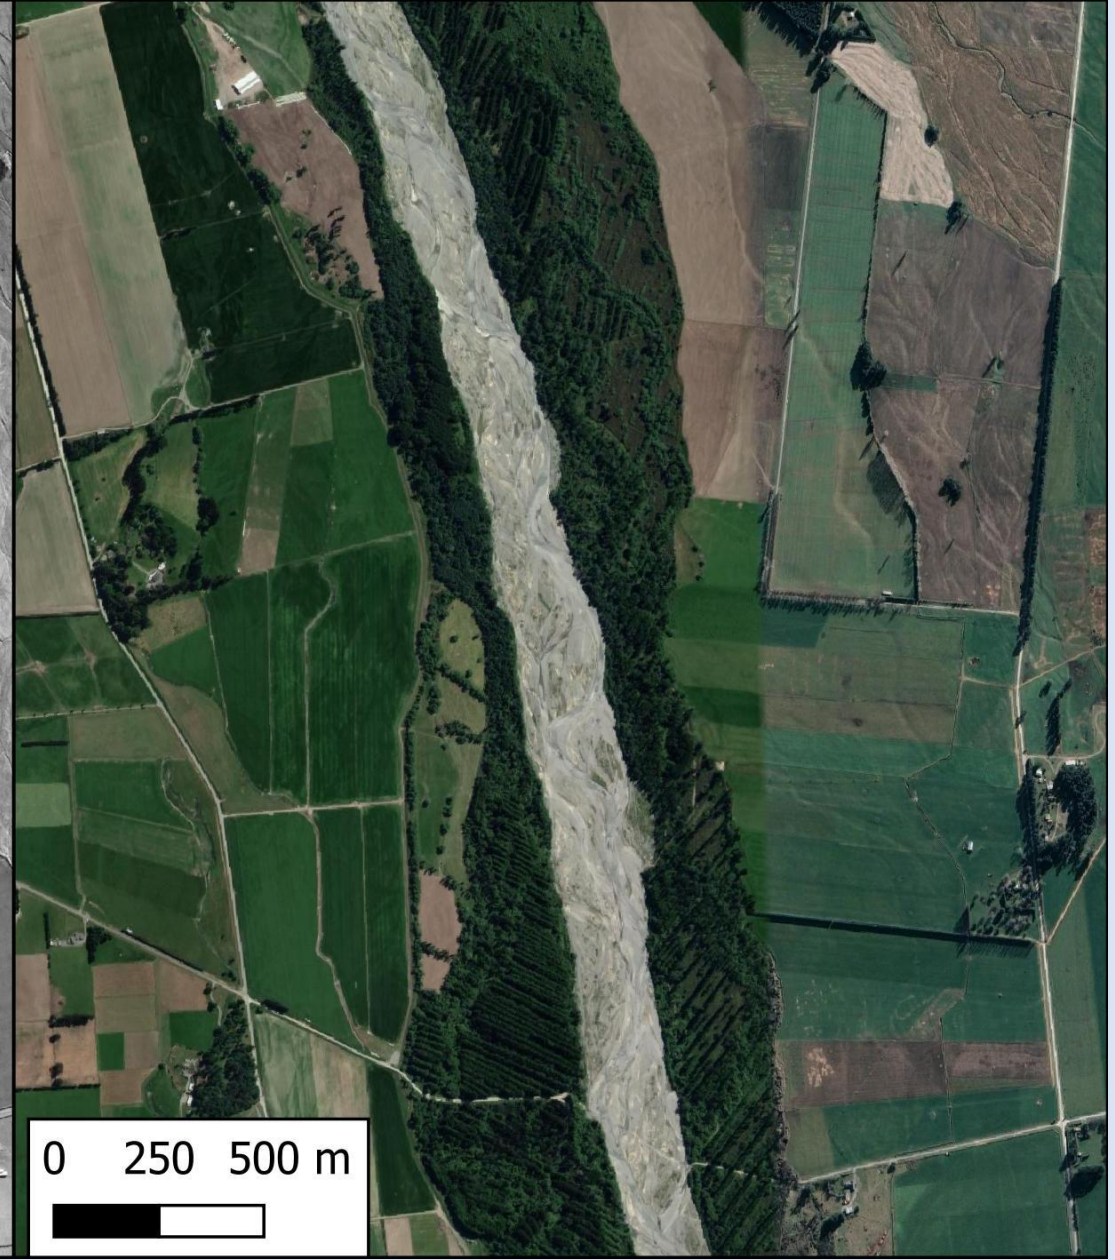
Orari 2020

Encroachment by Flood Protection – same objectives as for Opihi?

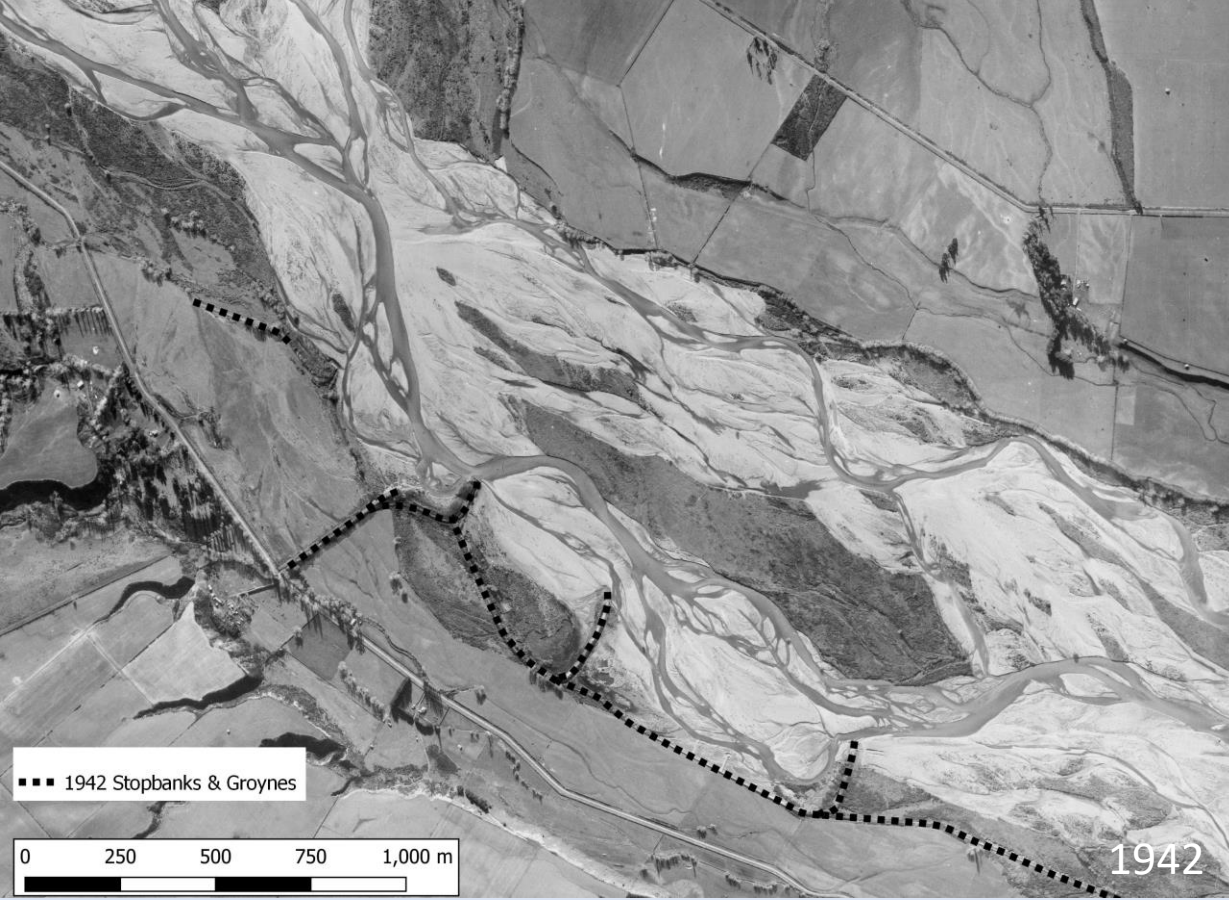
During freshes and floods there was a complex interplay between erosion and deposition. In this part of the river erosion rate was slightly greater than deposition. Towards the coast deposition > erosion.

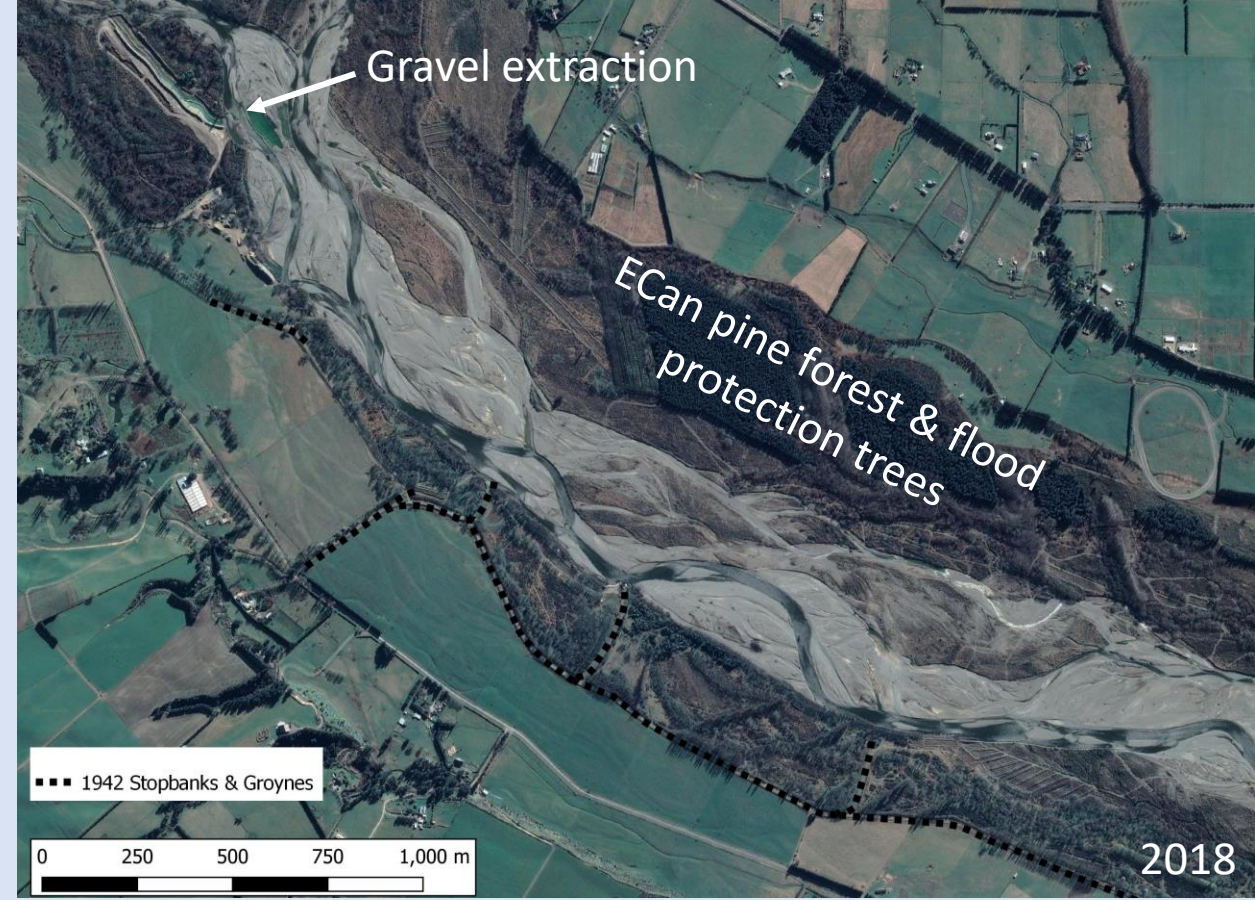
Flow is more confined, deeper and faster and eventually straighter. This will cause greater bed erosion with most deposition being sand deposited on the berm. This leads to greater weed growth, which traps more sand and grows more weed and narrows the river.

Fairway area is now 56% of what it was in 1942, partly due to positive feedback loops?

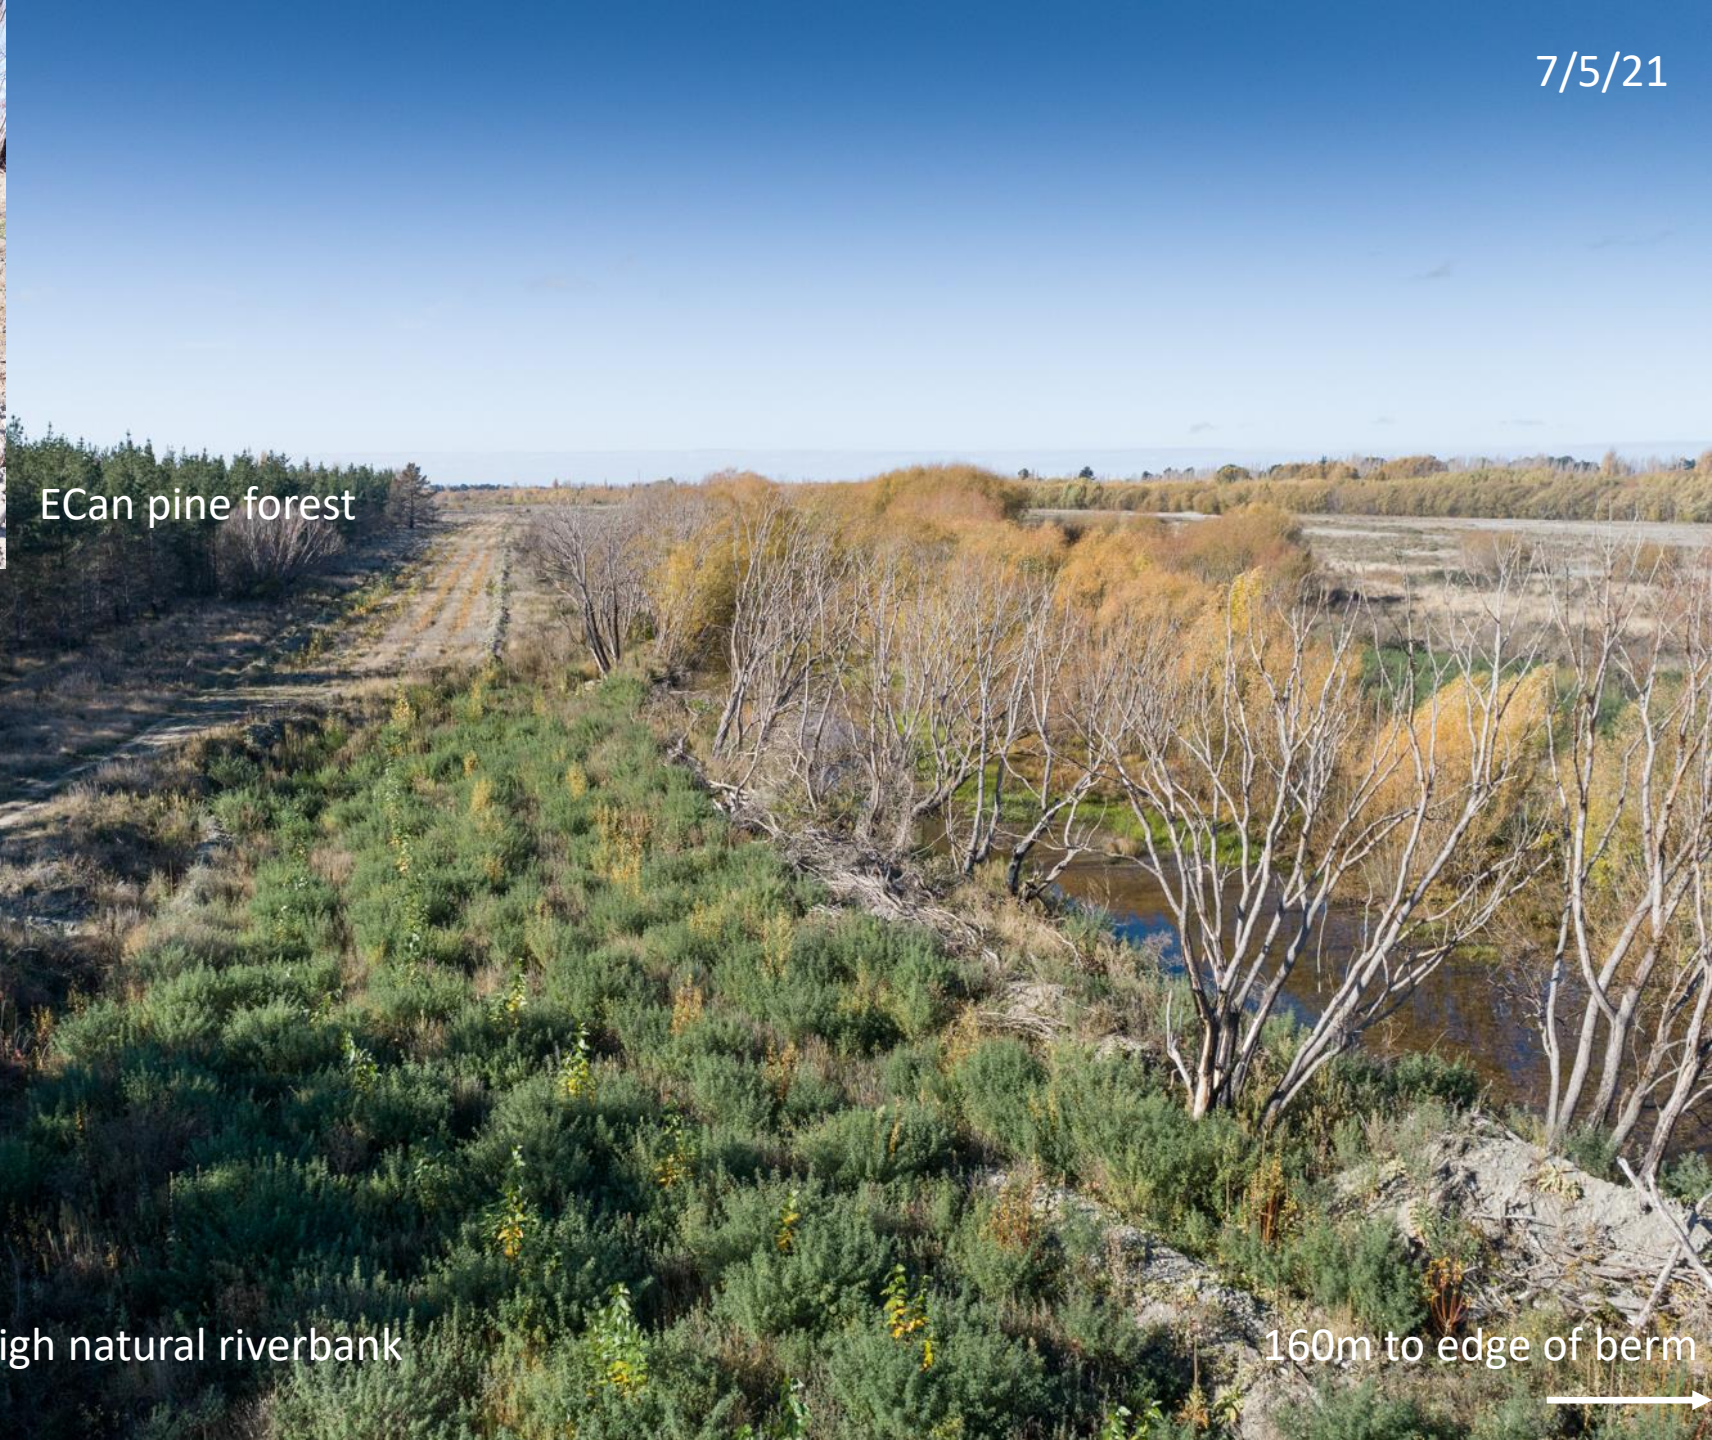
ECan pine forest

Flood protection tree
planting done in mid
2020.

400m to high natural riverbank

160m to edge of berm

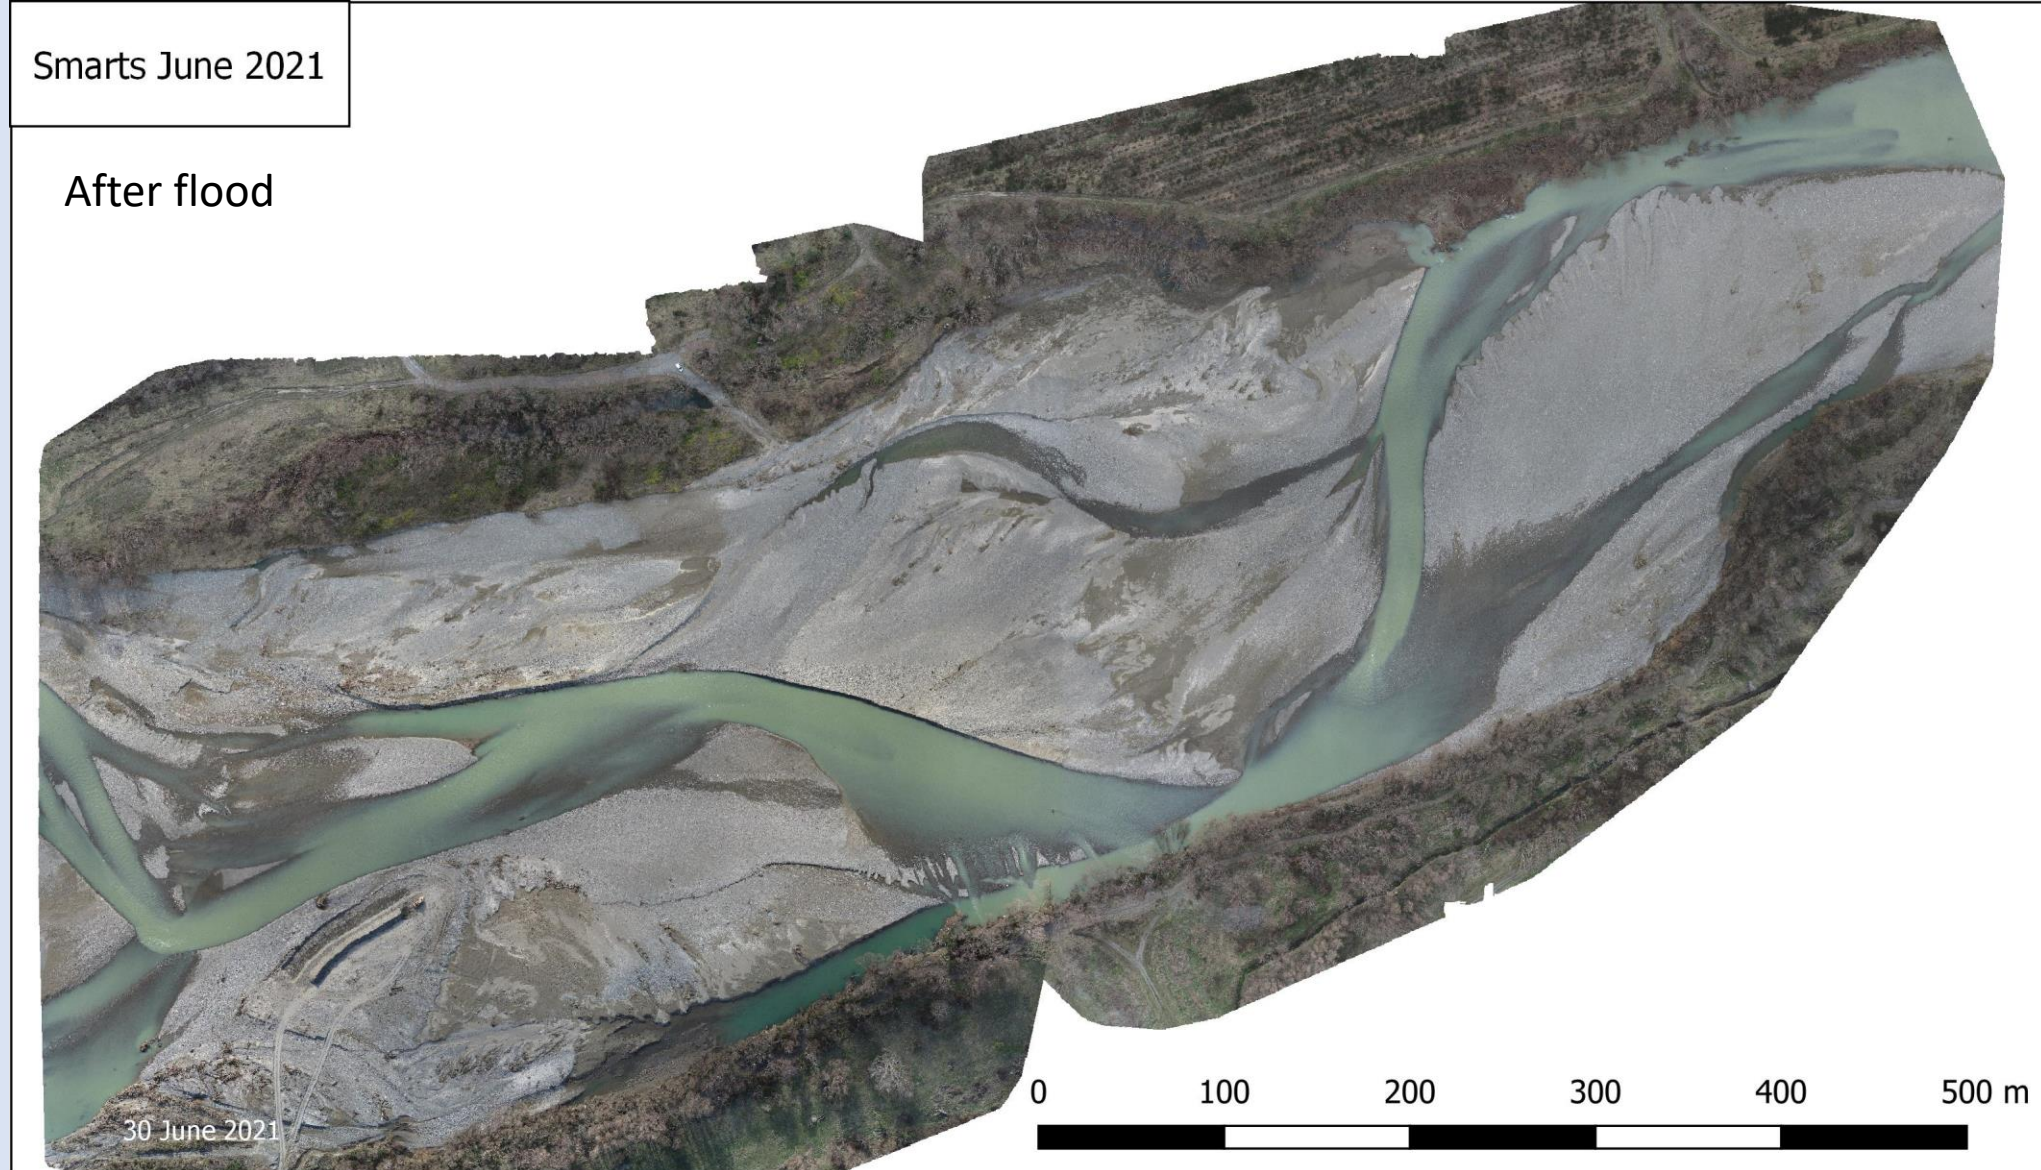
After flood

But – the major flood this year completely remade the geomorphology of the river, removed weed and left most surfaces sand-free. Smaller floods do not remove weeds and they drop sand on the islands.

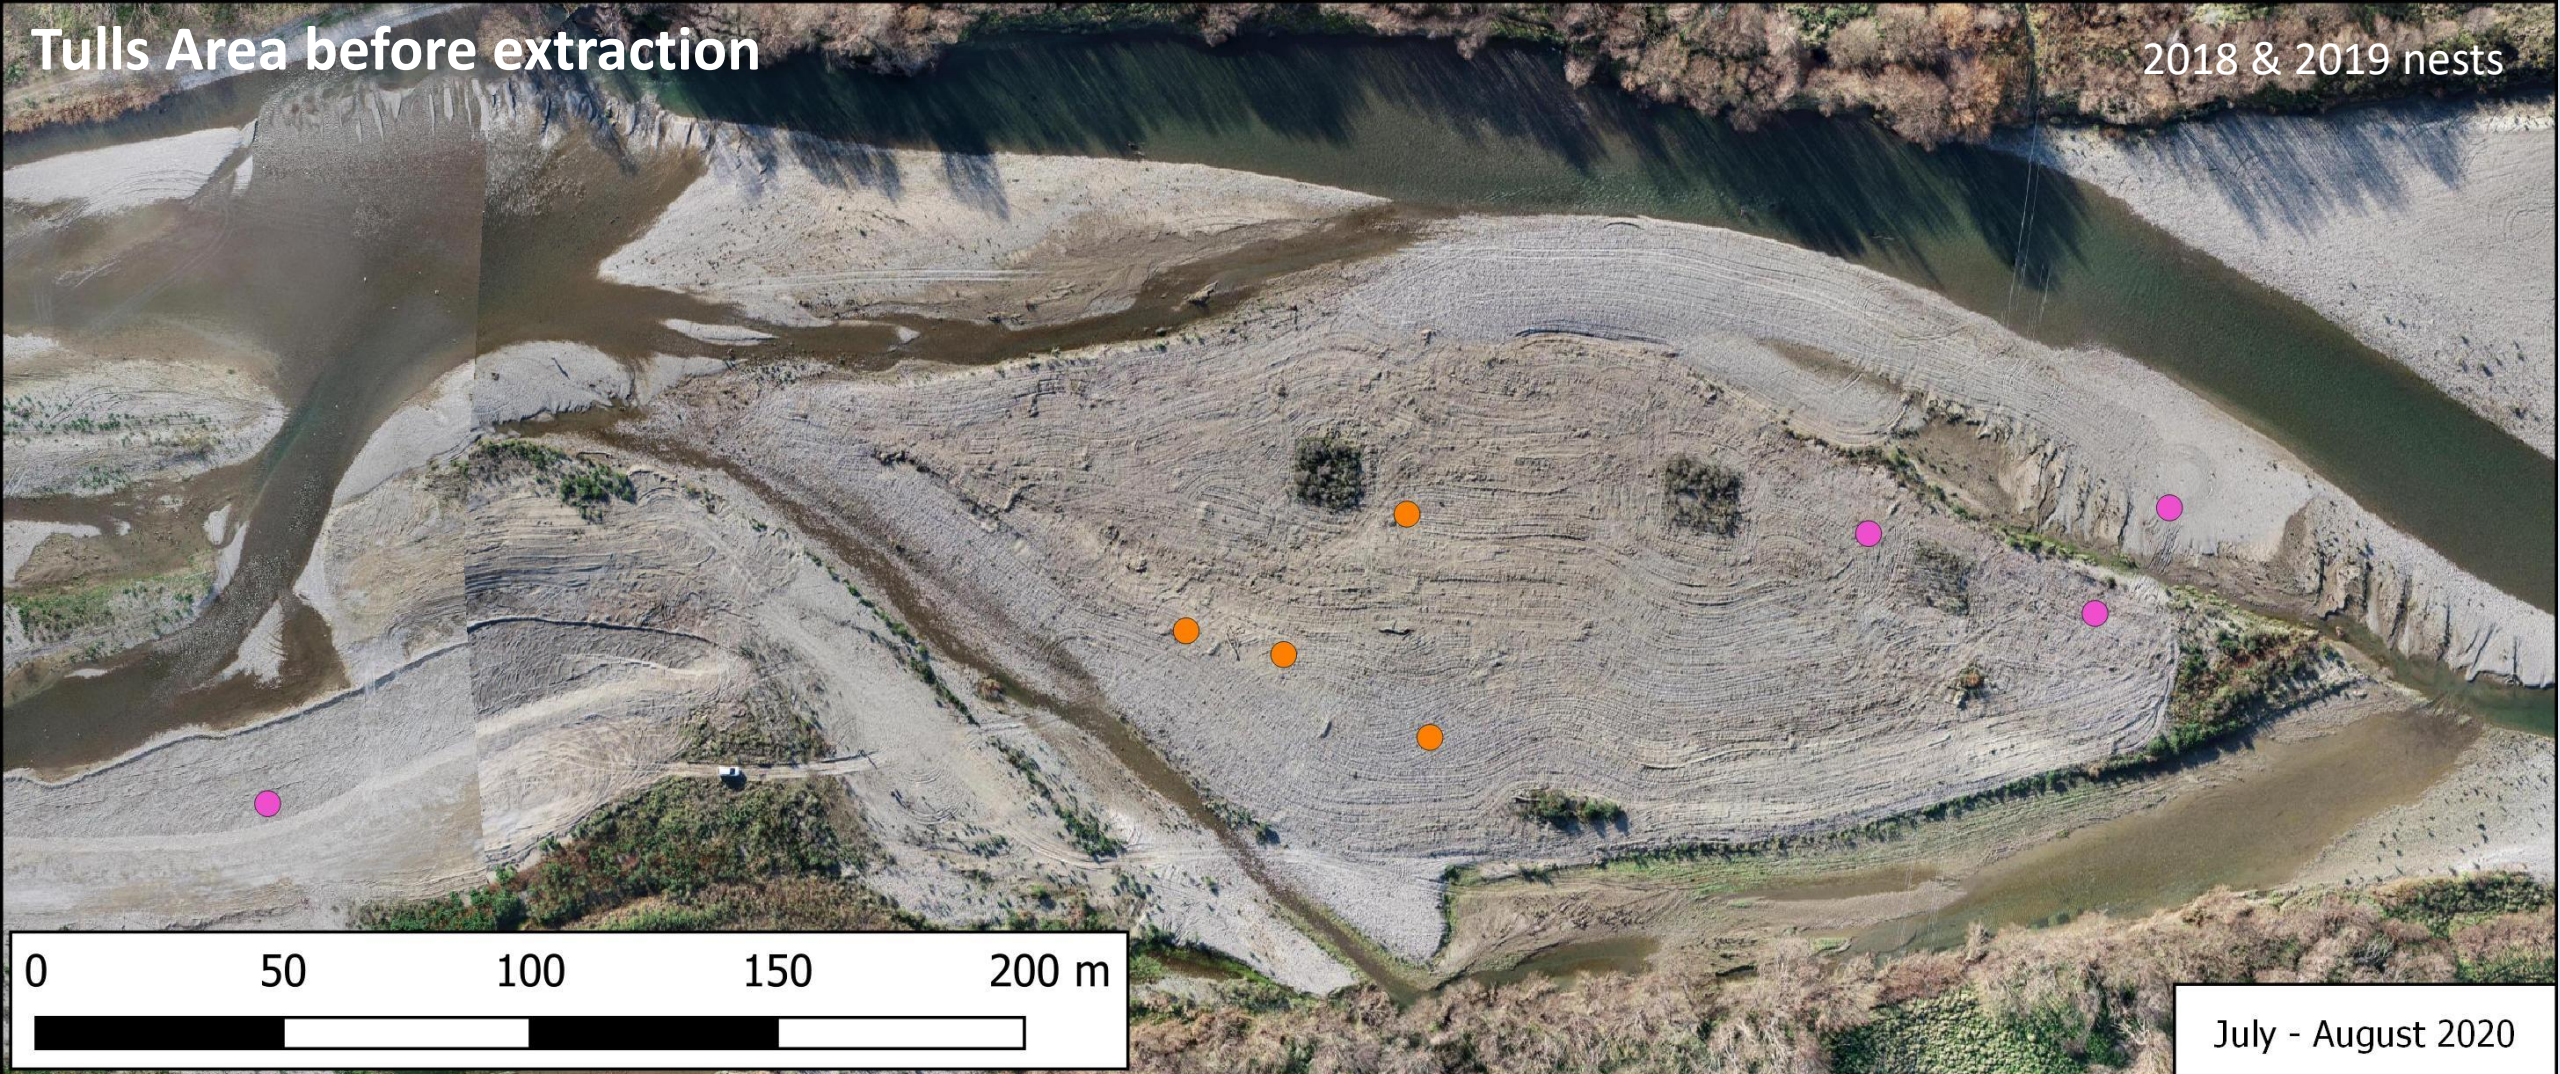
- Superficially excellent bird nesting island – initially good flow around it but substrate too sandy and upstream gravel extraction cut off southern flow
- Cleared of weeds three years running by ARRG (ECan funding)
- Subject of a PhD study (Sanaz Safavian) on weed regeneration, DOC insect study and ARRG monitoring
- The above not notified of consent application, not consulted in consent process, not notified that consent was given

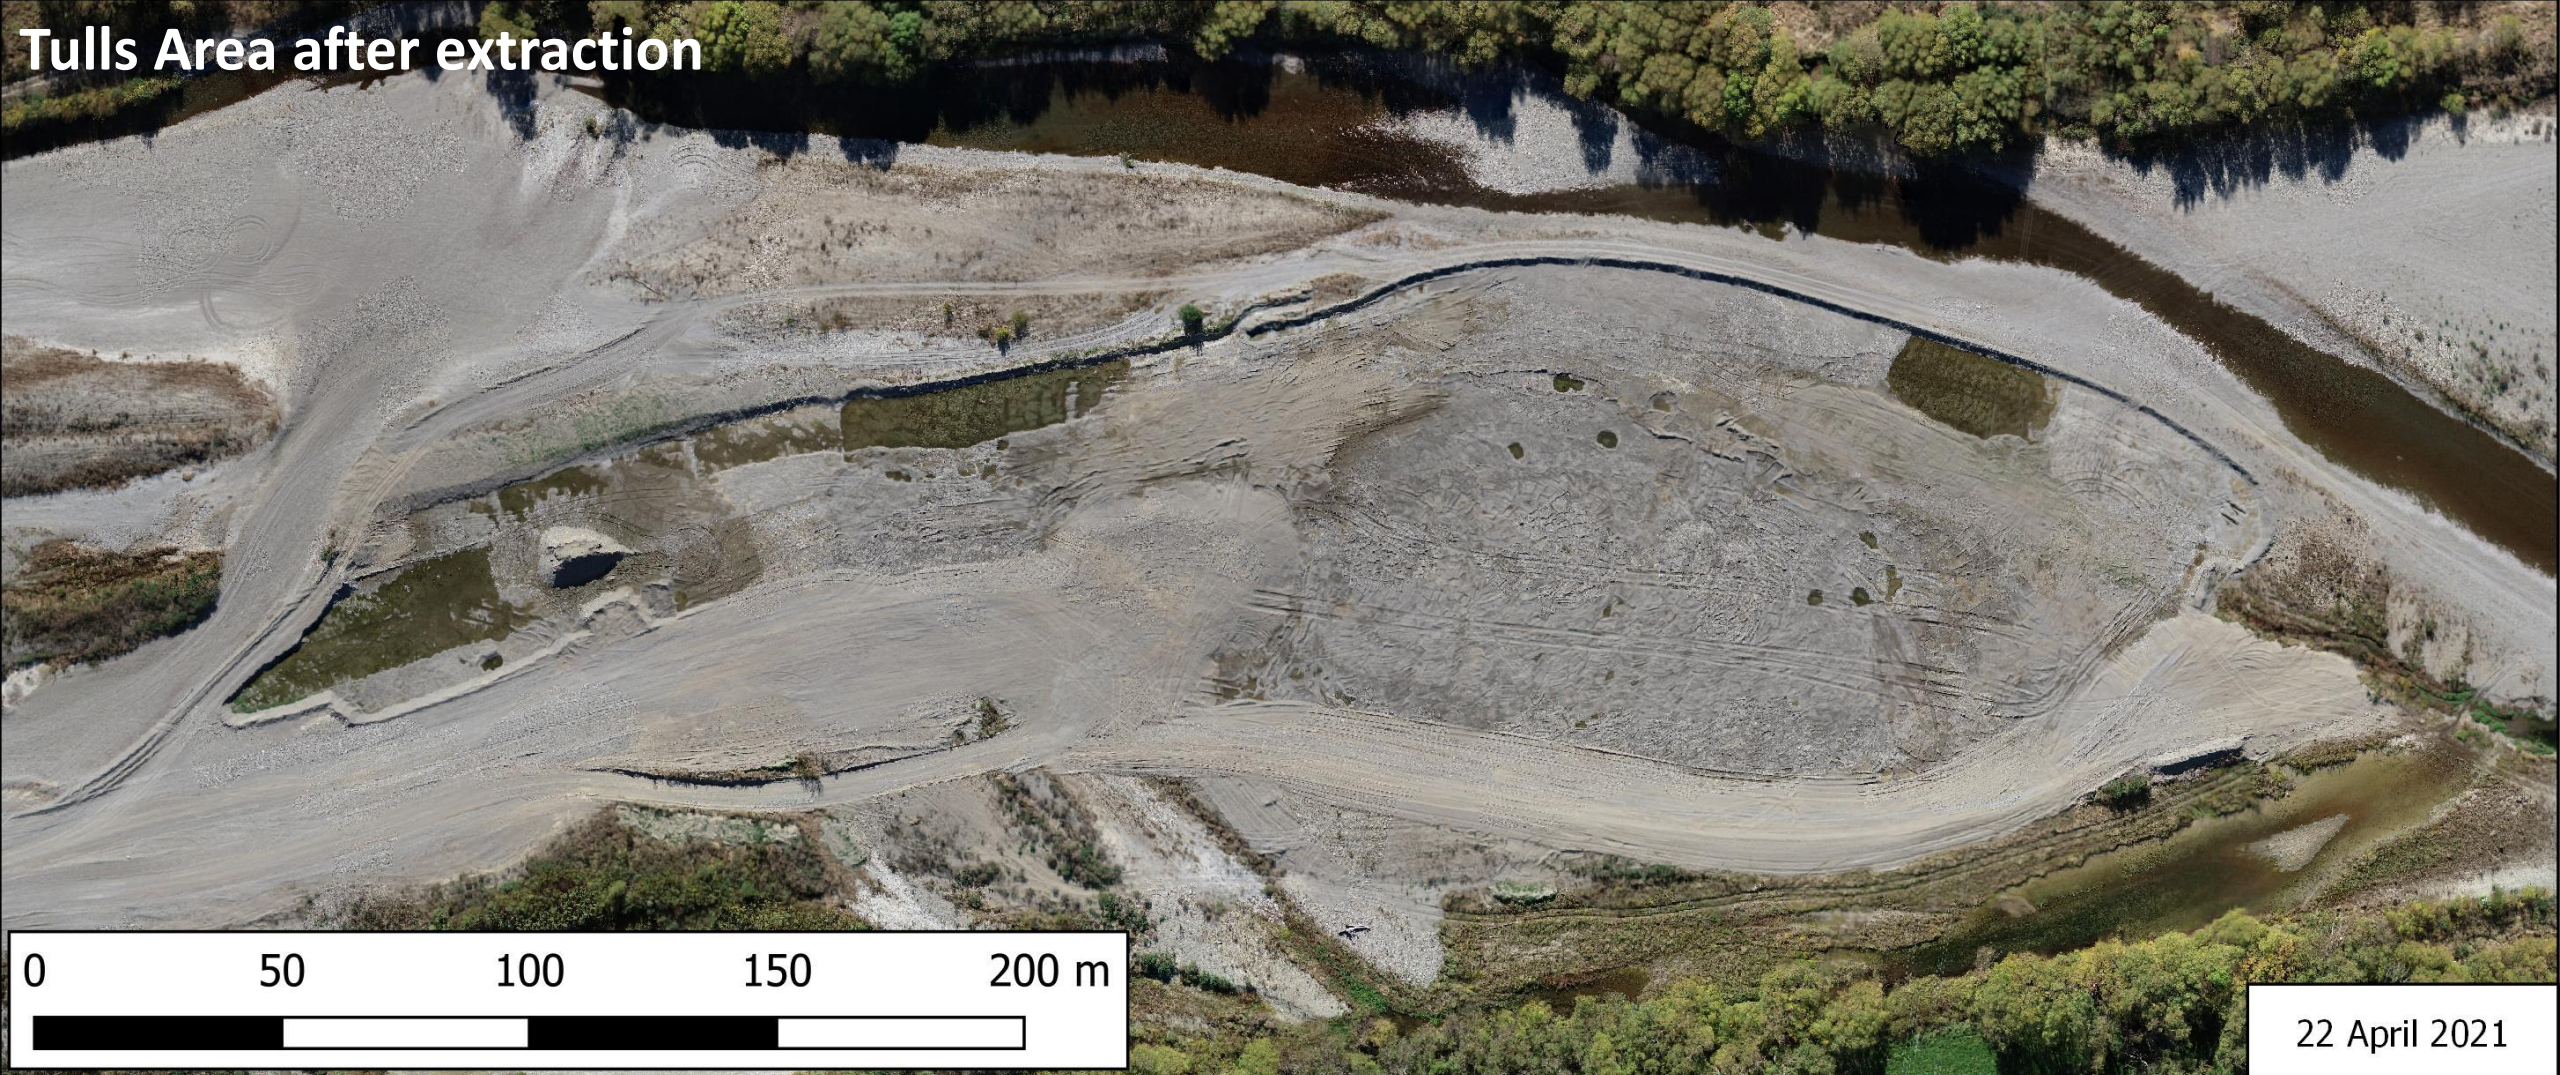
Started January 2021, completed March 2021, 35,000 m³ consented
