The Plight of the Foothills-fed Canterbury Braided Rivers

Ashley River, July 2020 - not a natural landscape

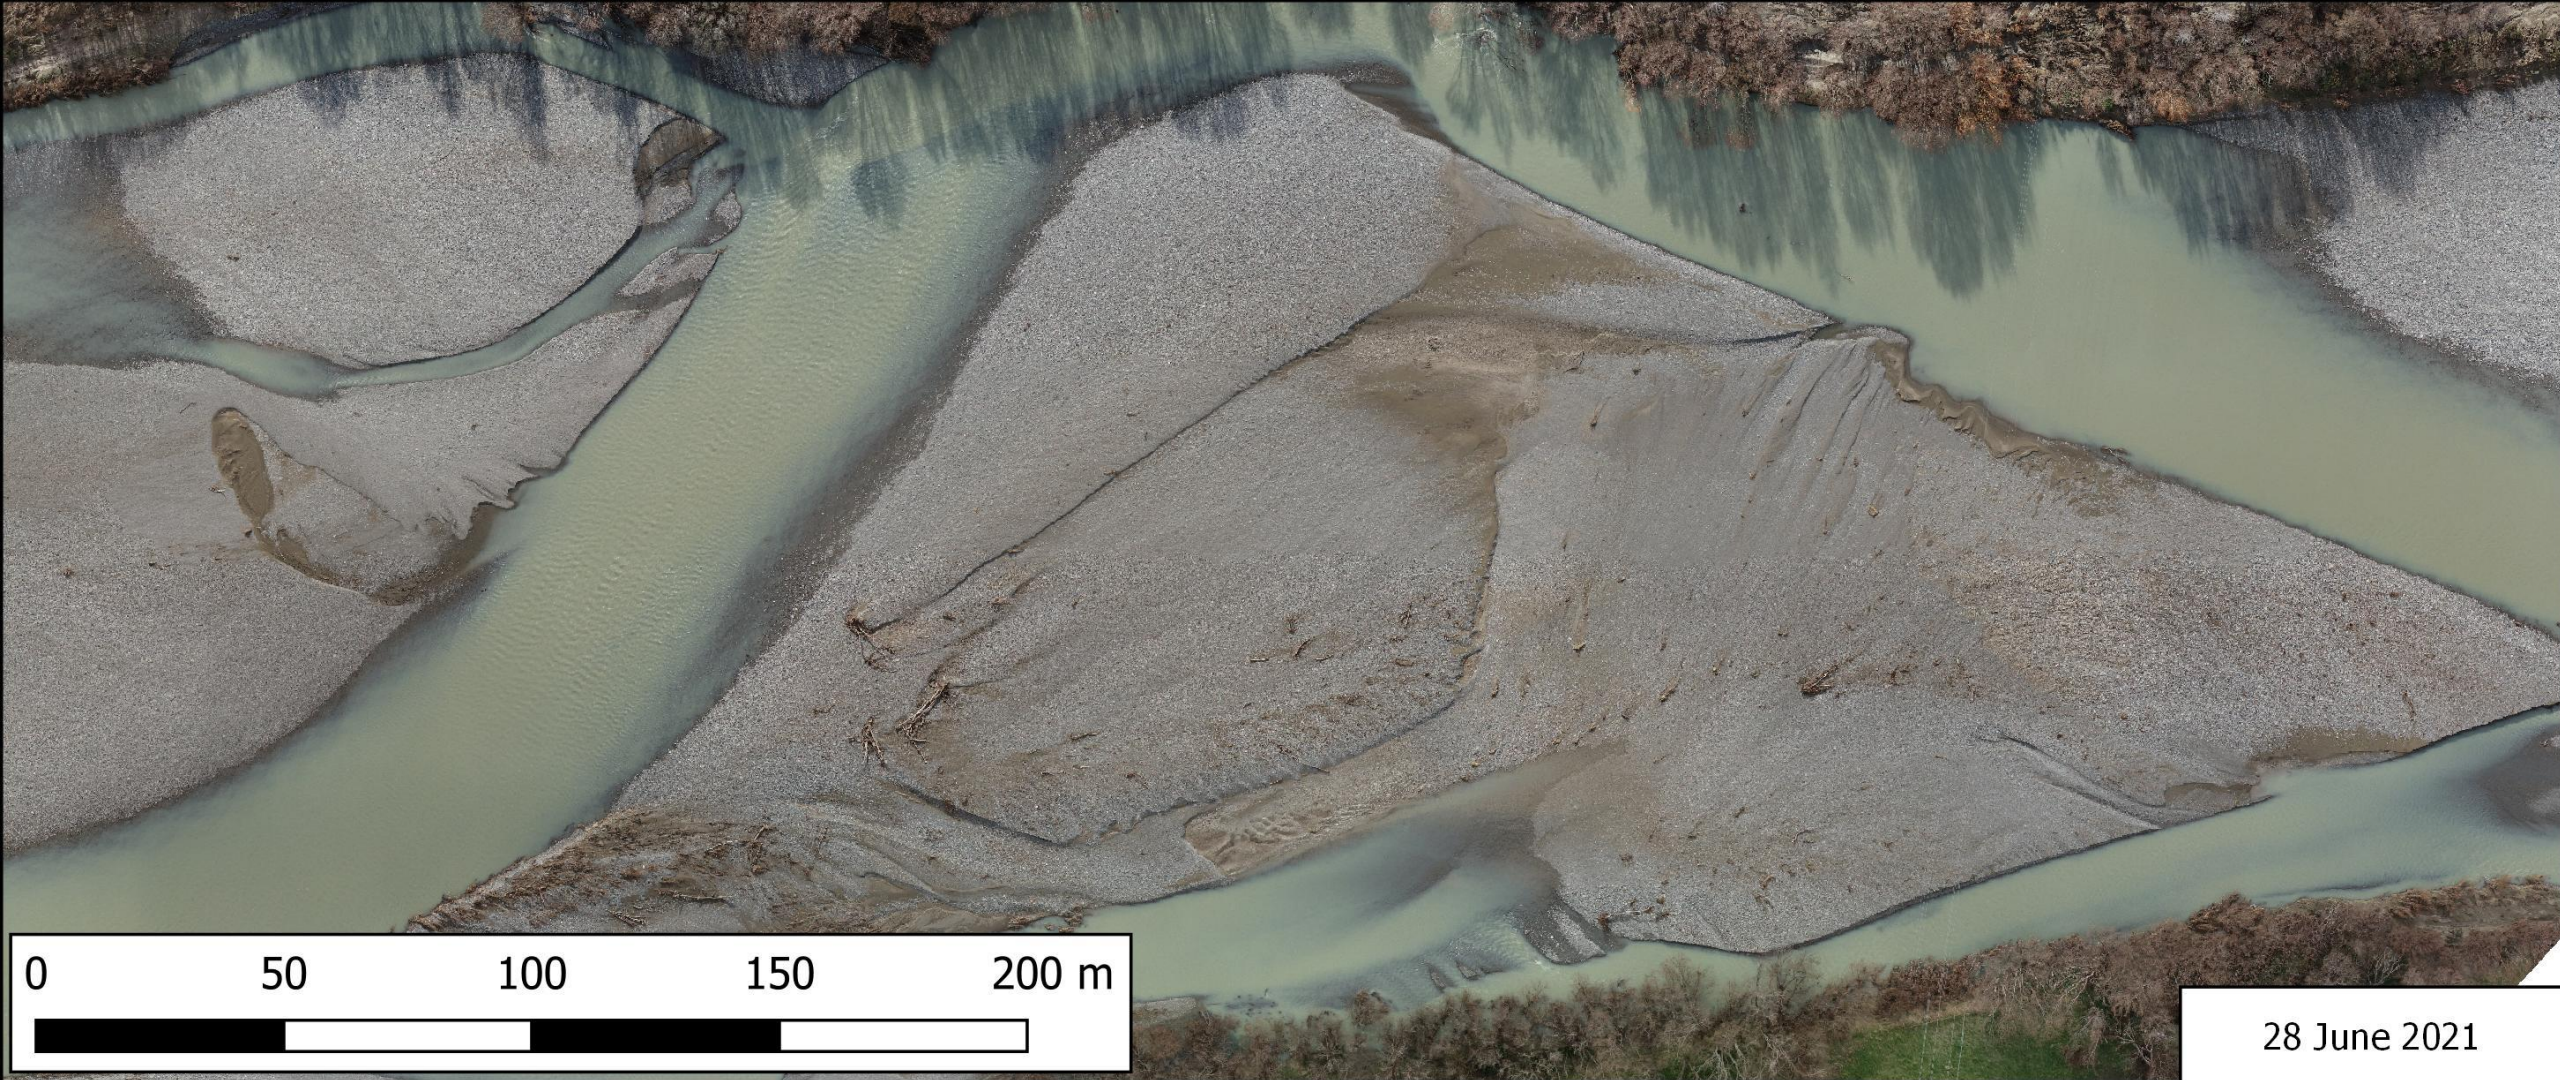
But – the major flood this year completely remodeled the area and reinstated the island – 3m of gravel deposited in excavation

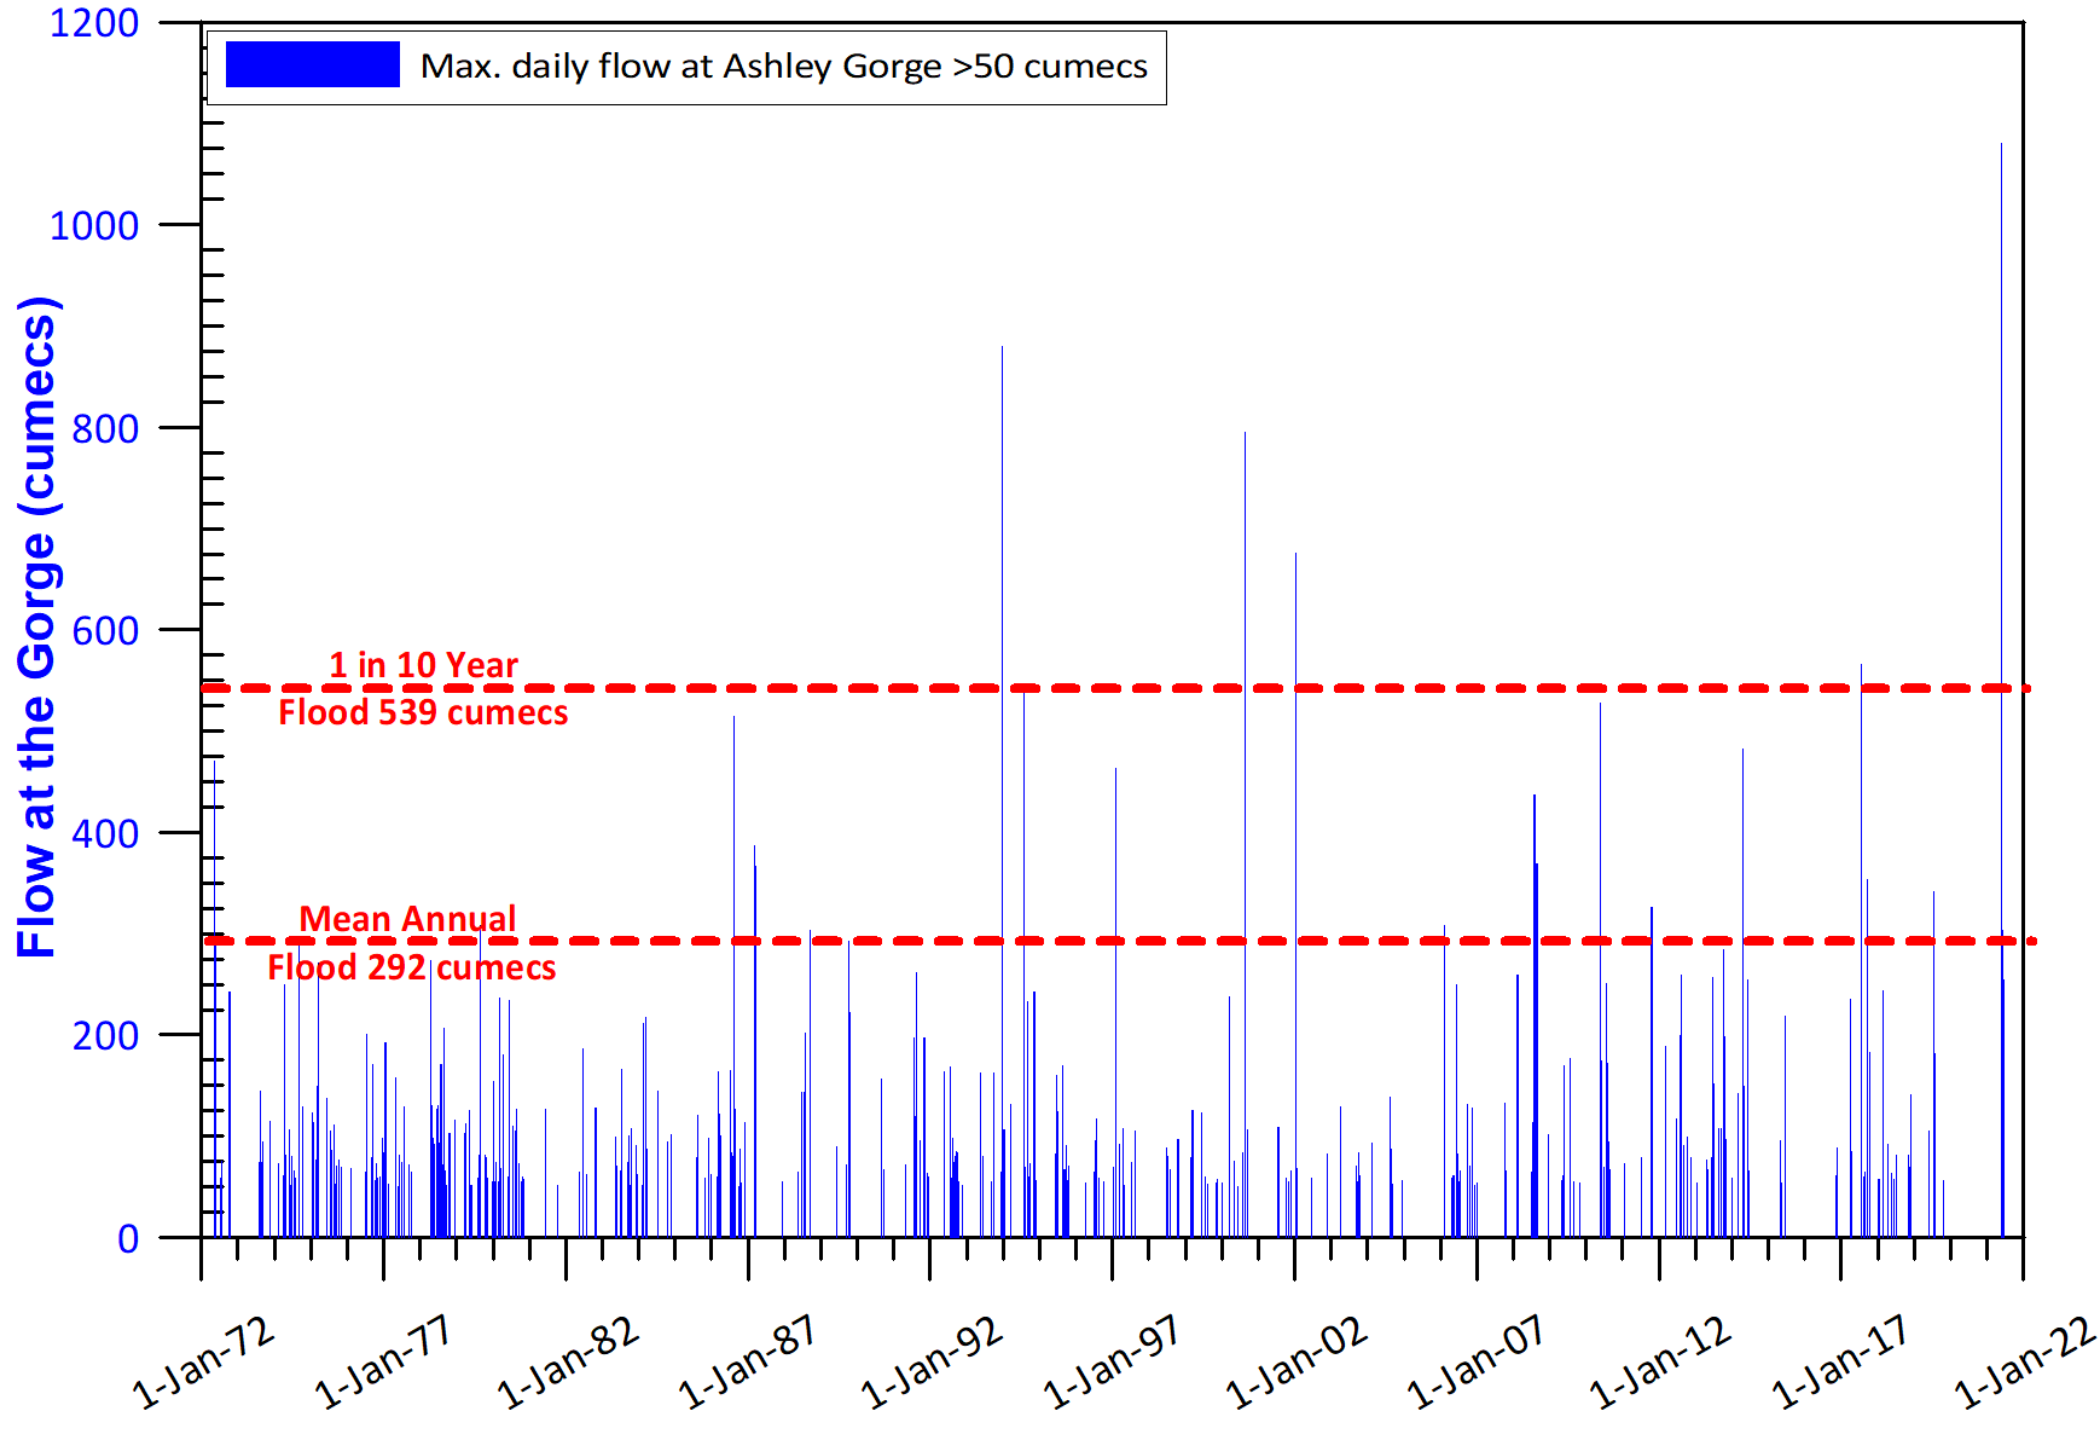
Ashley Flow at Gorge

A flood of approximately 1 in 10-year recurrence interval is needed to remodel the river and create new nesting habitat

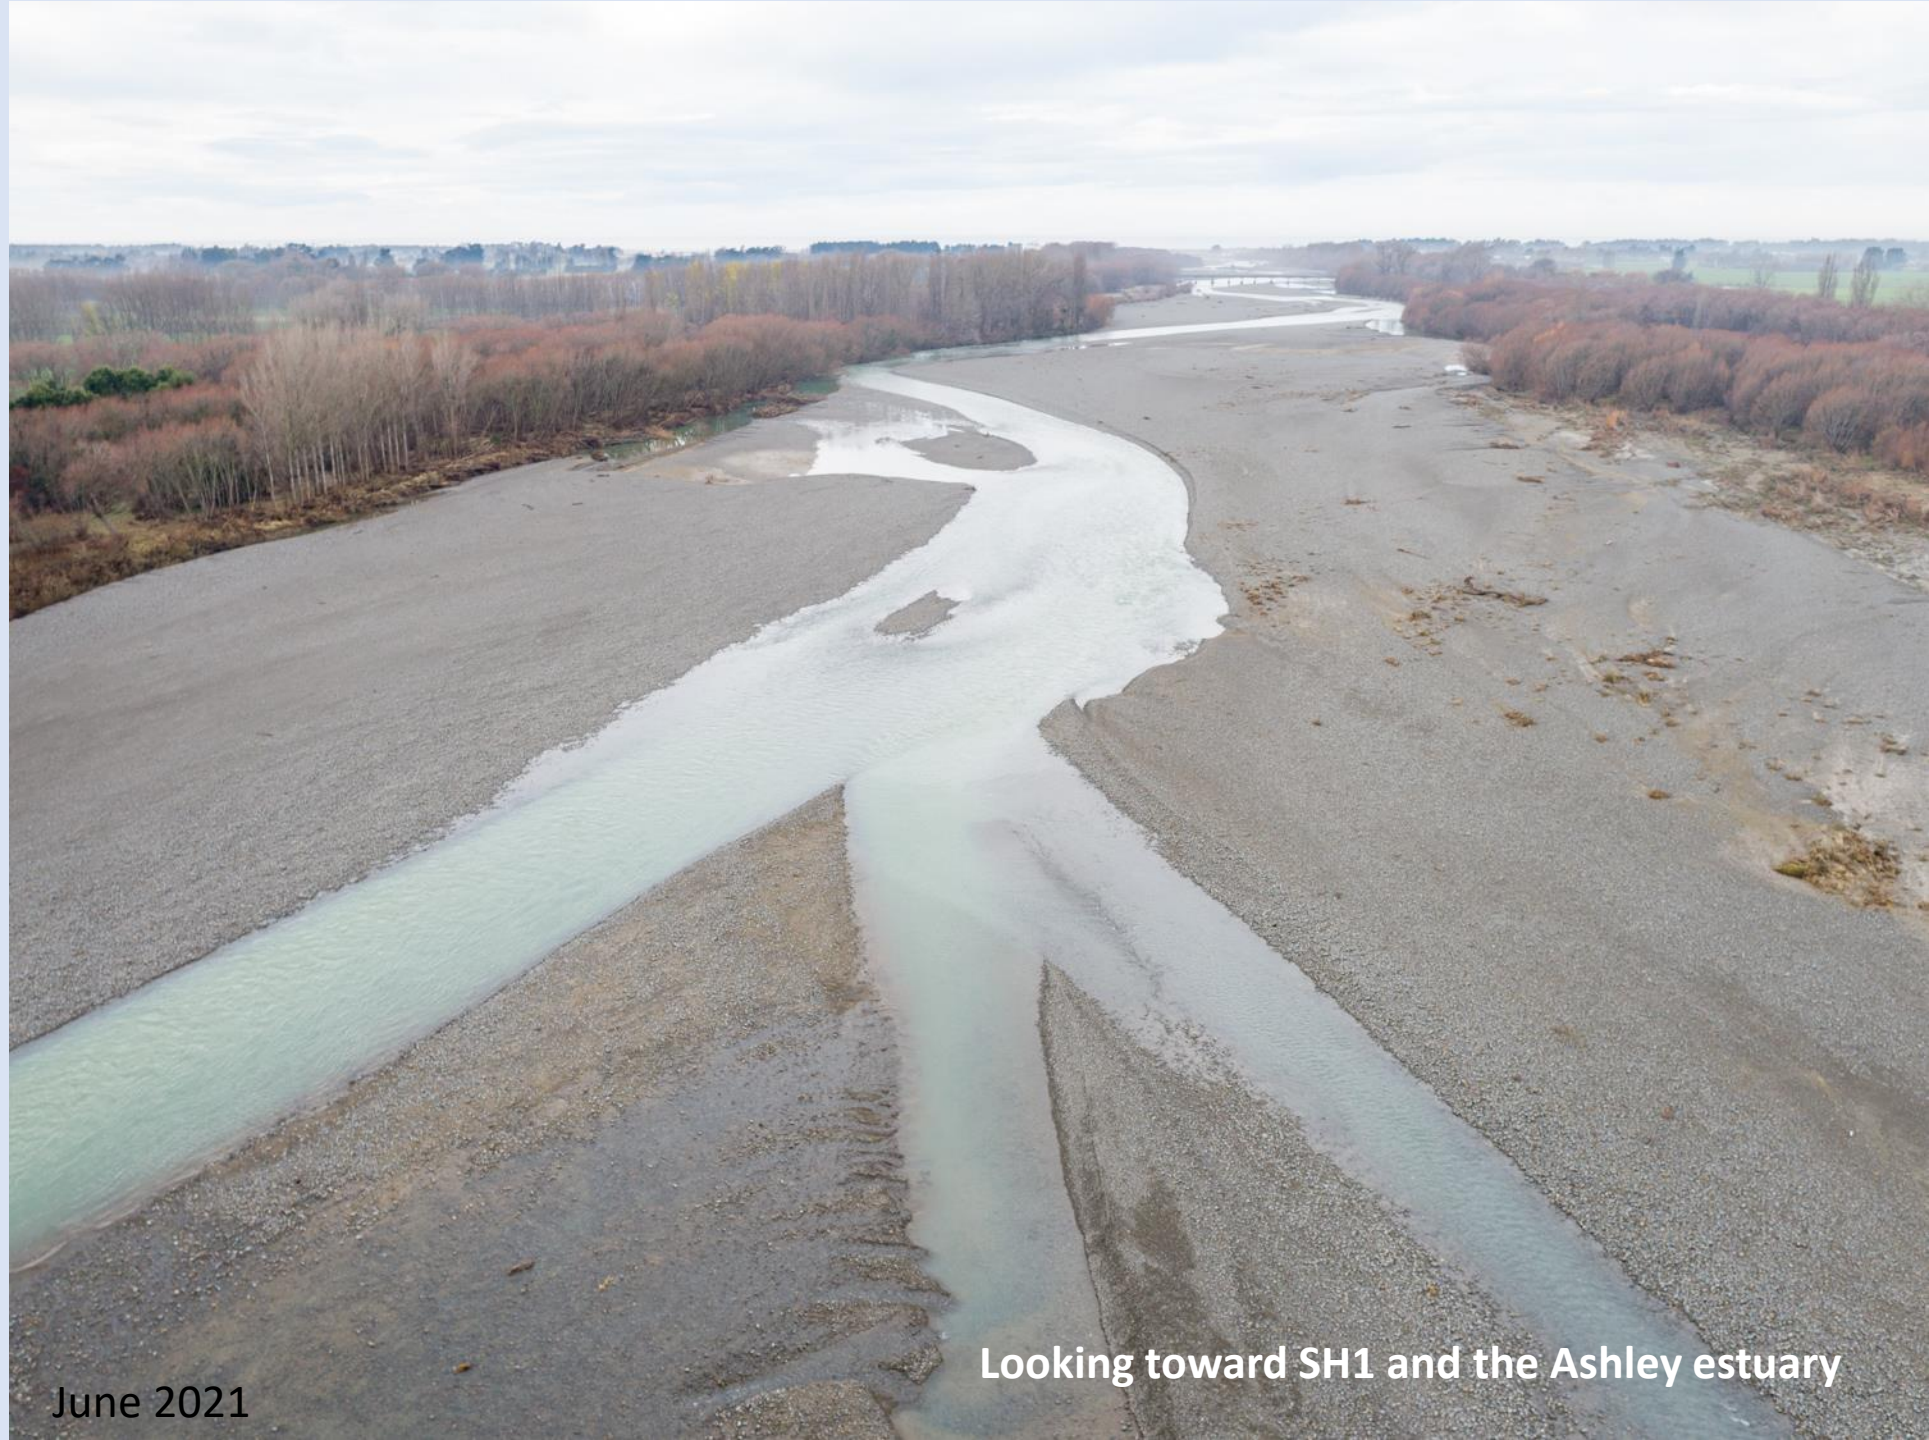
June 2021

Where the river is too narrow a braided habit is impossible.

The major flood increased the width of the fairway, but did not increase the amount of braiding.

Looking toward SH1 and the Ashley estuary
