Aspects of the Weed Problem, Colony Nesting Sites, & Predation In 2019

Grant Davey and Nick Ledgard

BRaid seminar, July 8, 2020

Protecting braided river birds
in the lower 20km of the river
– downstream from the
Okuku junction.

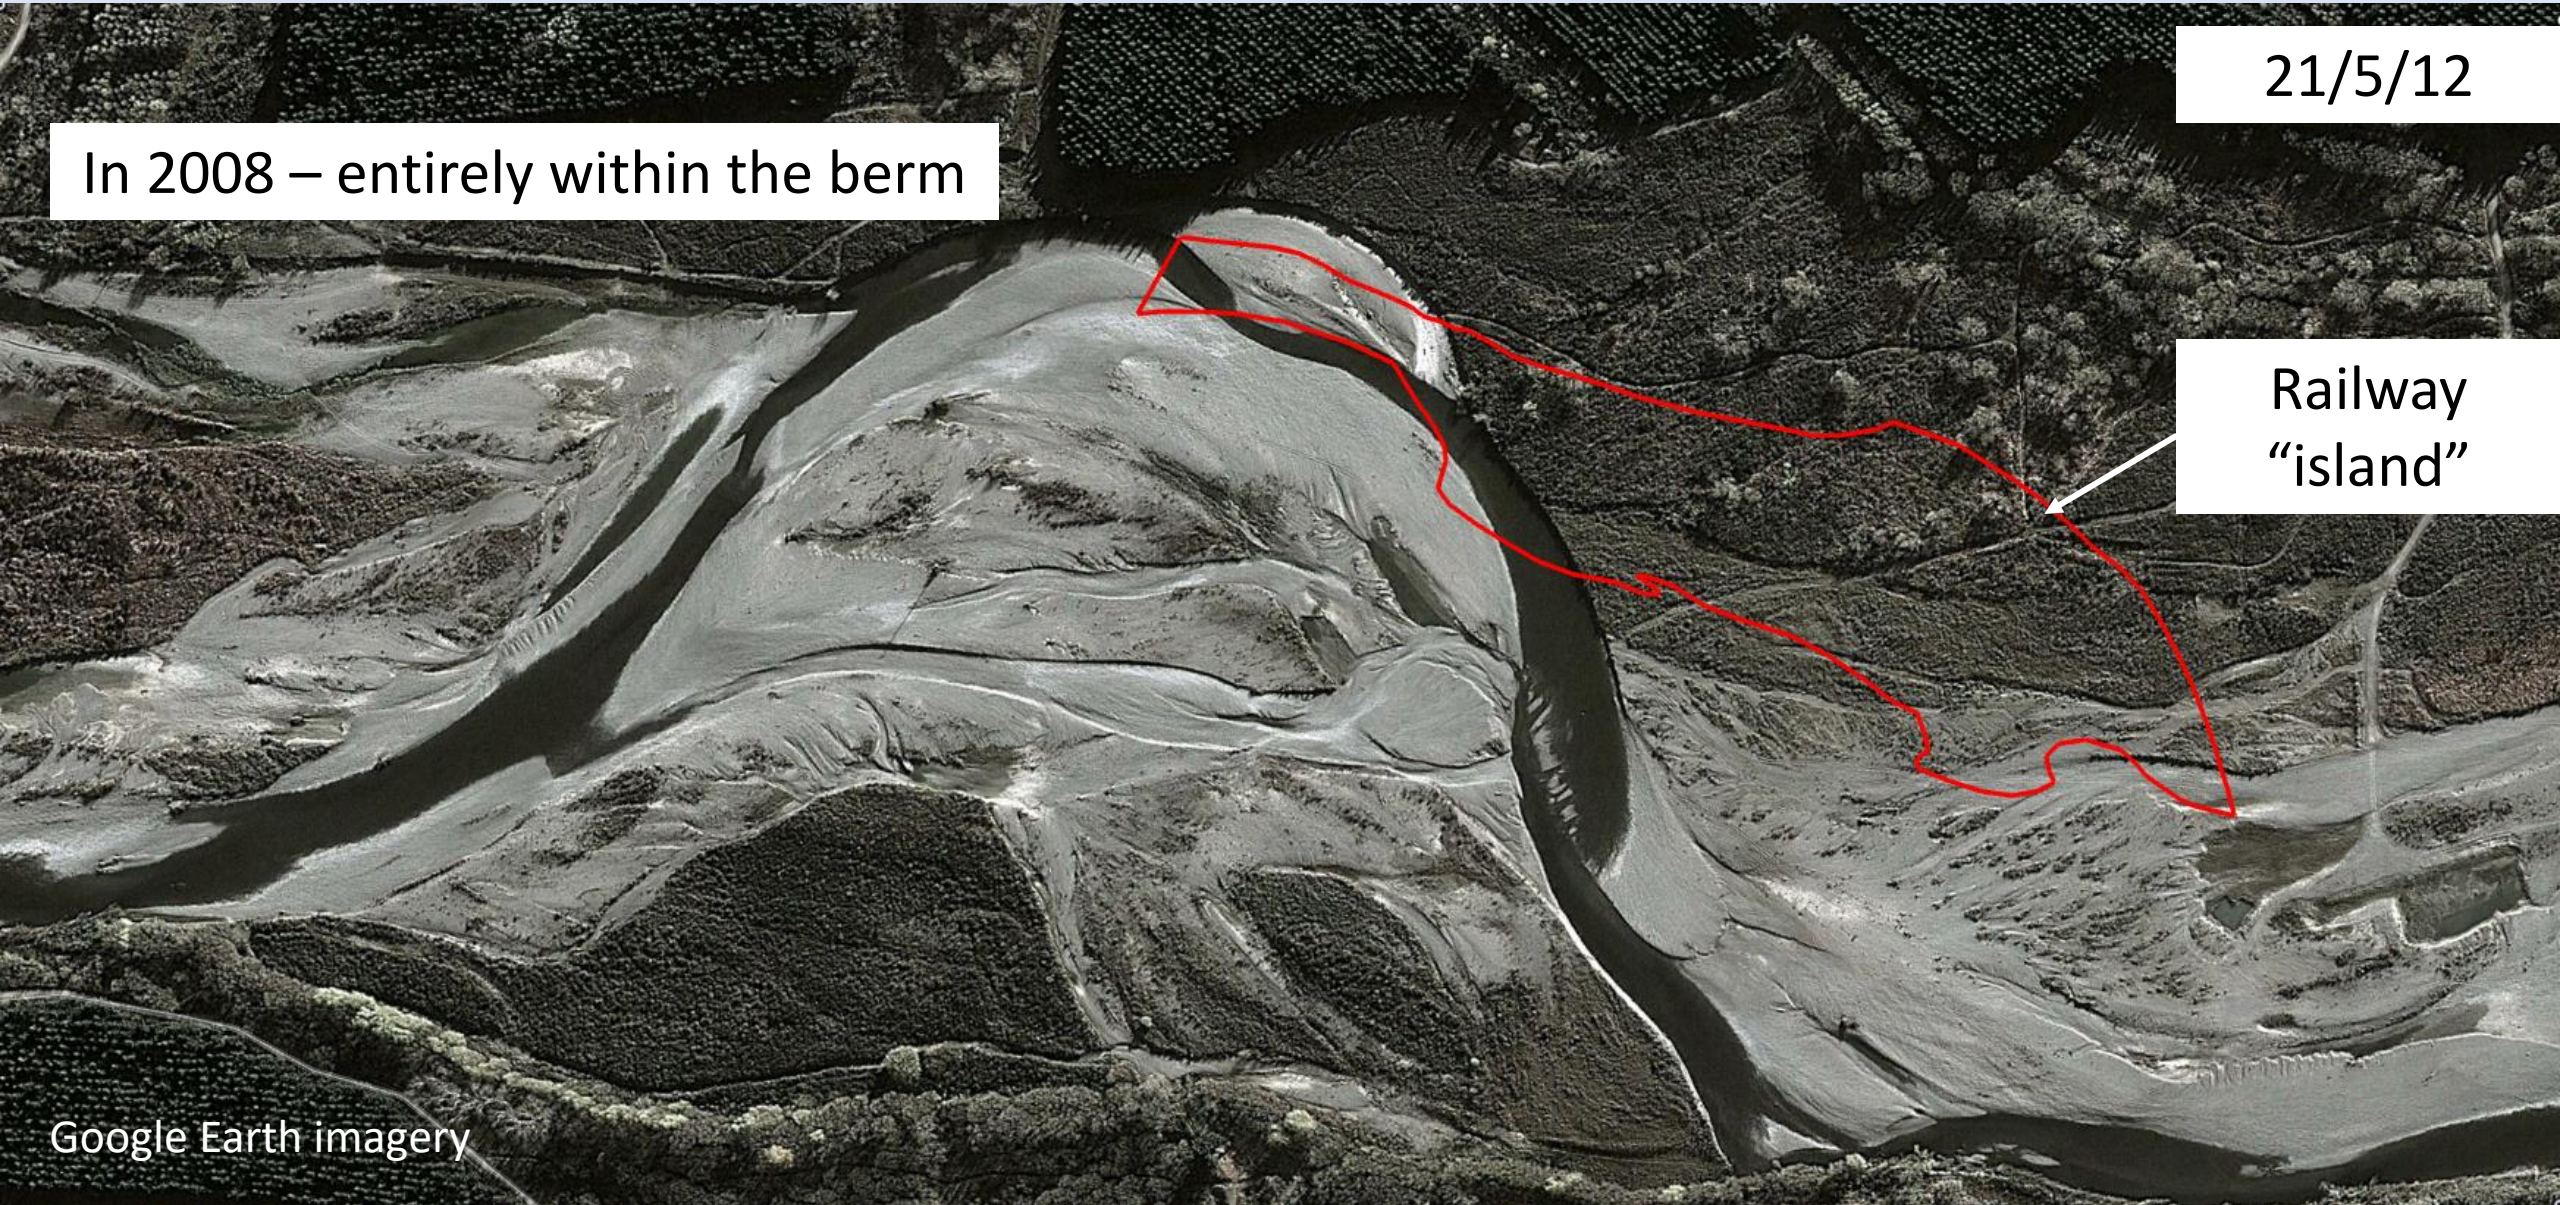
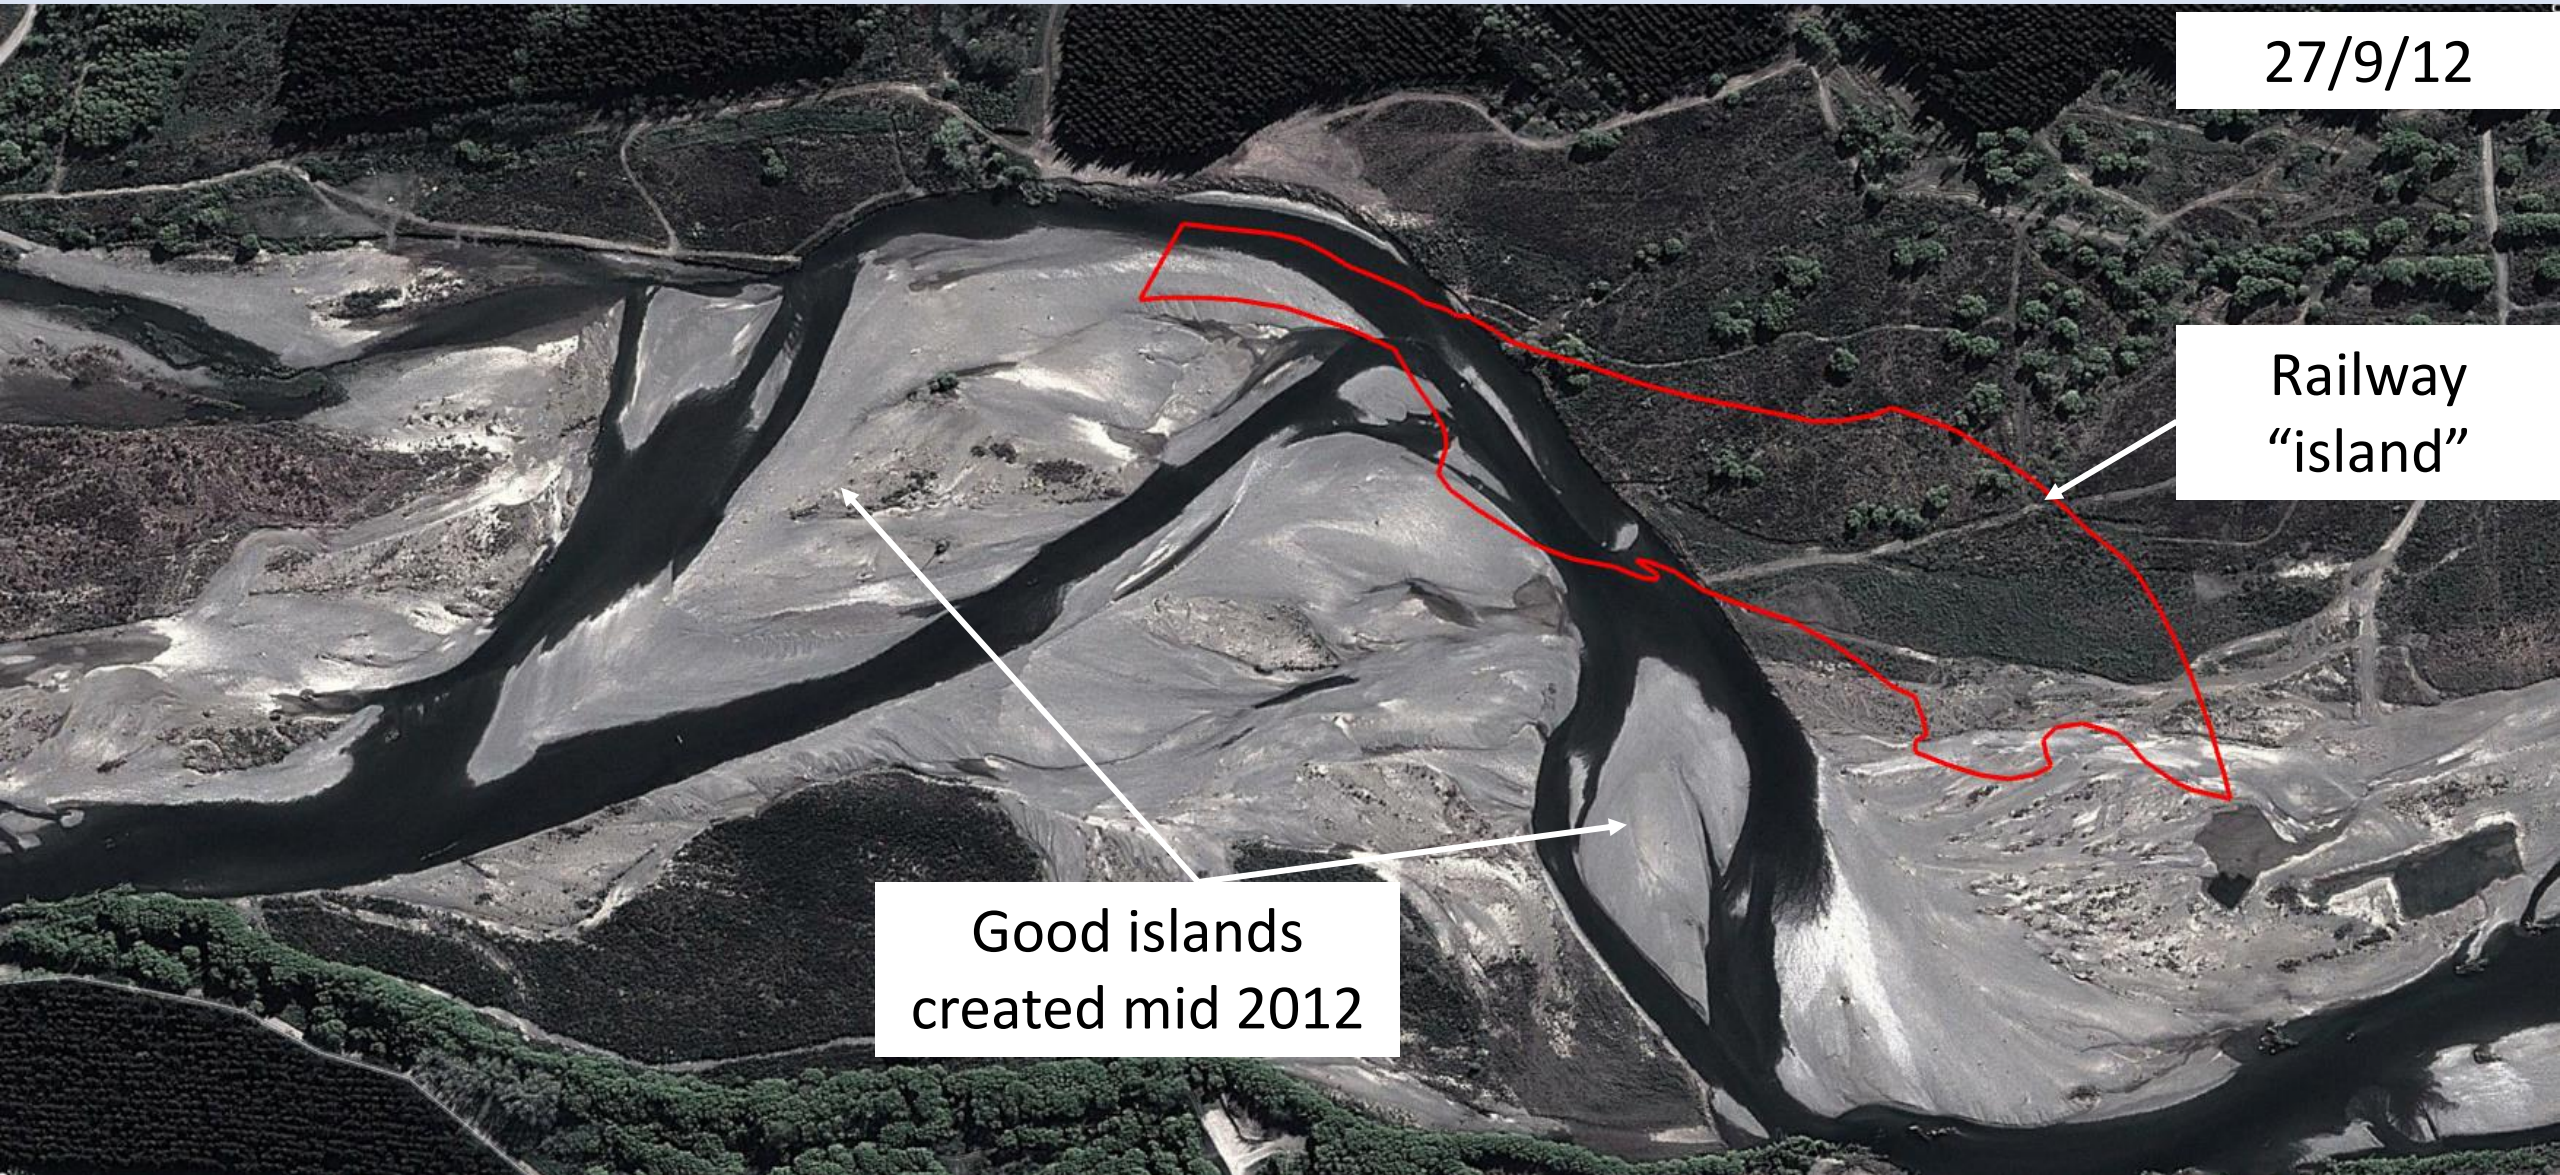
Railway island history - 1

Good islands
created mid 2012

Islands gone in 2
years

- All 2019 colonies were on sites created by the July 2017 (1 in 10 year flood) or by the July 2019 (mean annual flood event). It was not a matter of flood waters just clearing weeds – they constructed new bars and islands for the birds to nest on
- The river environment is extremely dynamic, we can't expect to clear weeds at a site for several years, use up the seed pool and have a long-lasting nesting area. We can't expect birds to be nesting in the same sites year after year – because those sites may not be there

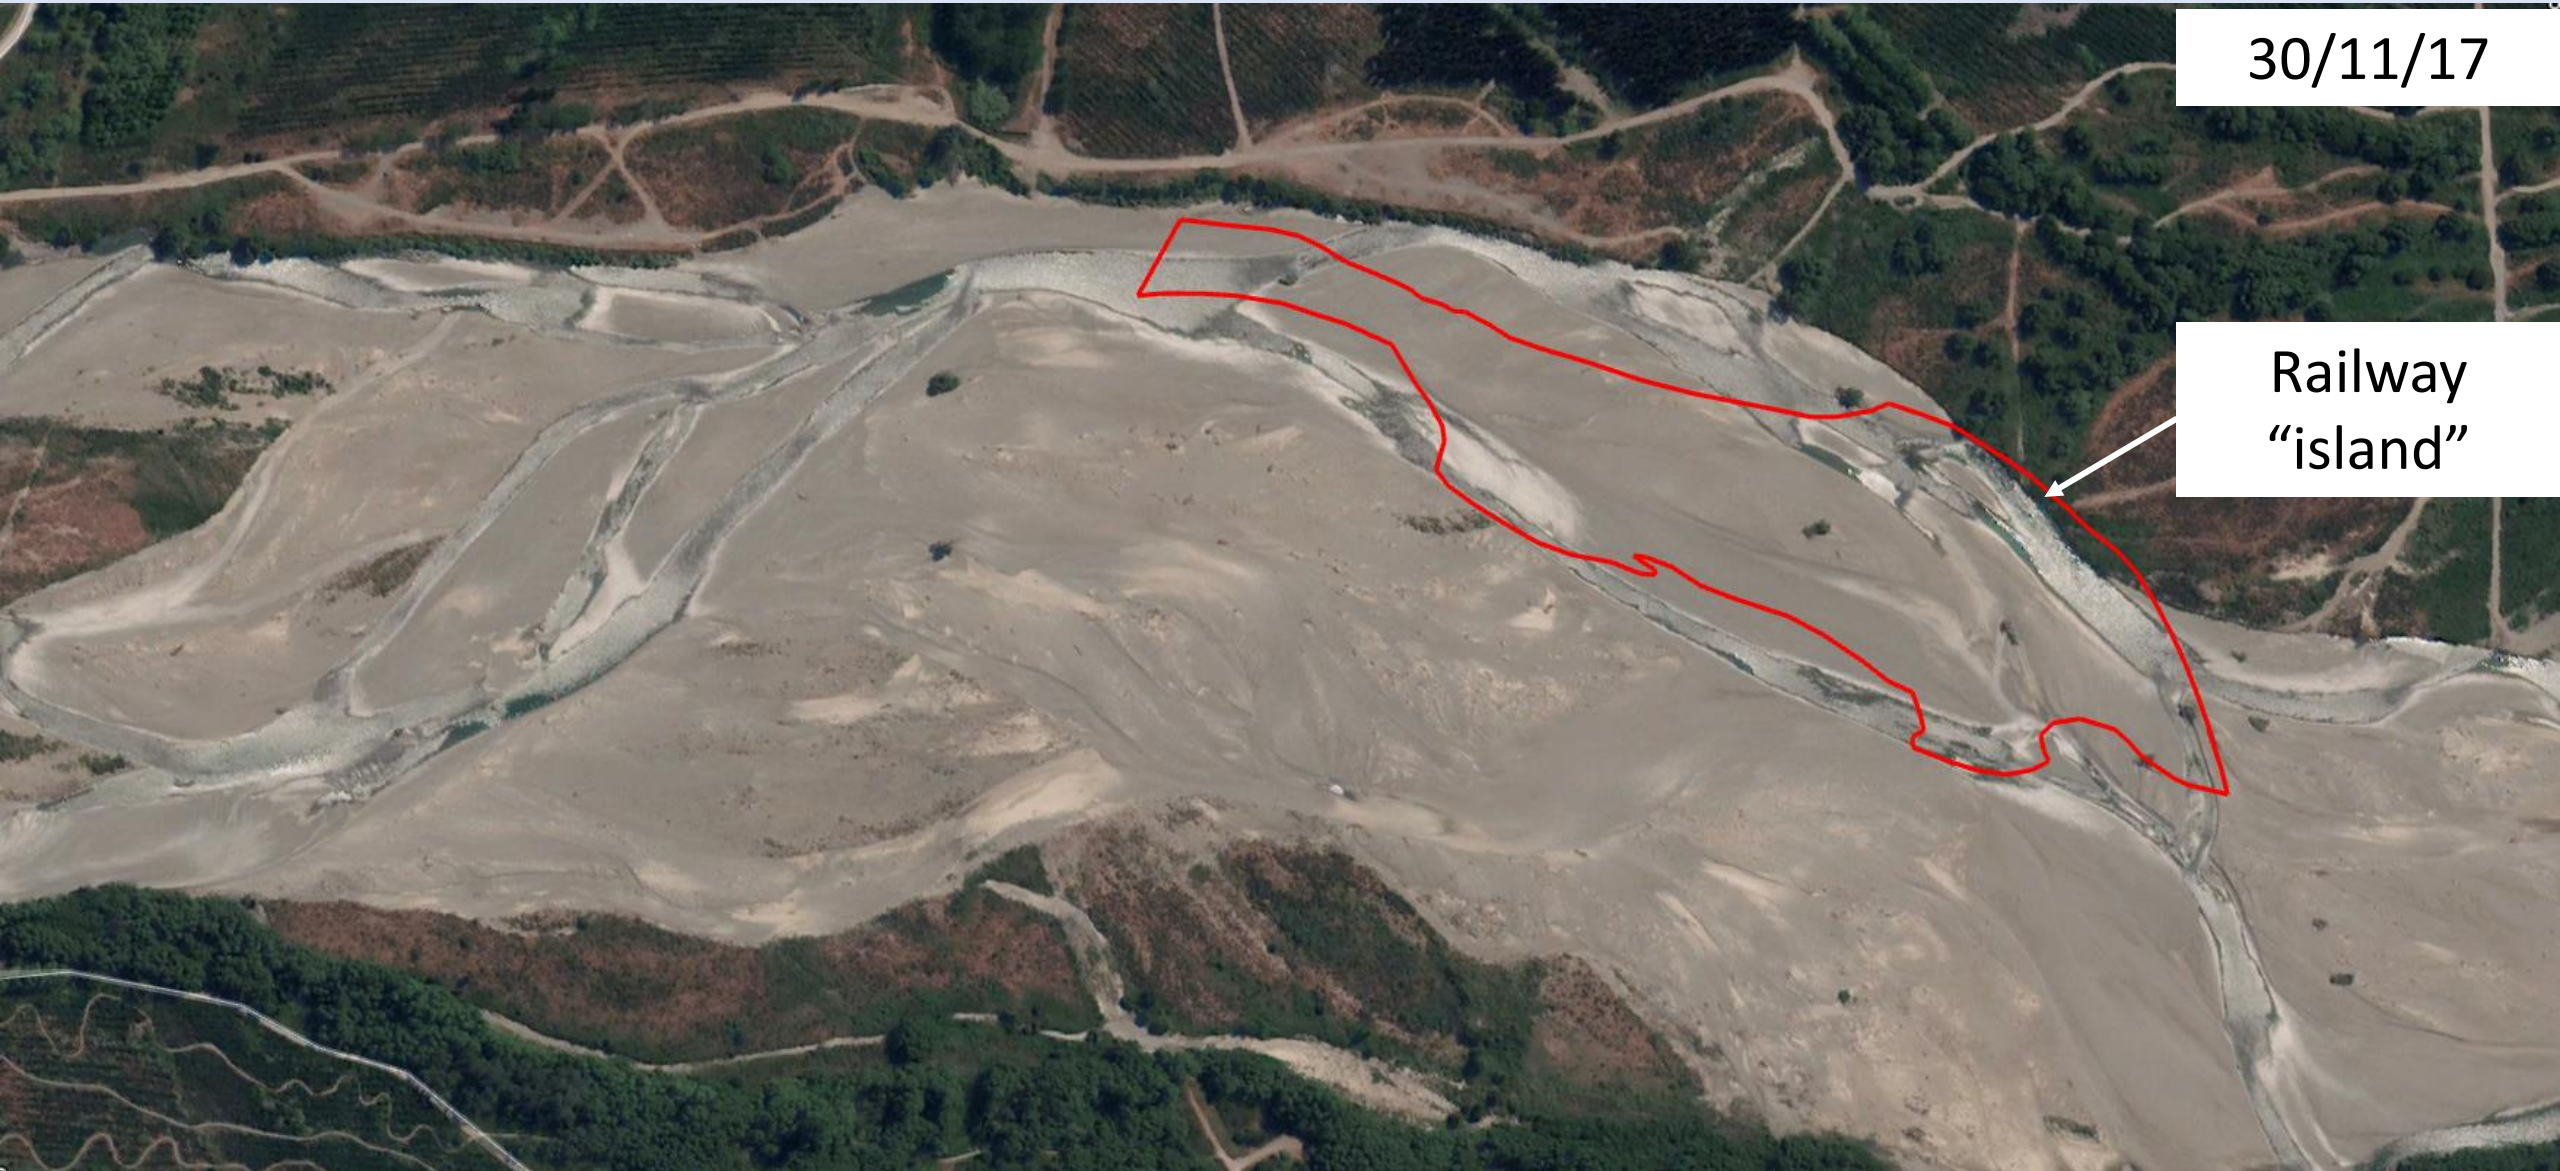
Railway
"island"

Island has current shape. But becoming sandier from smaller floods

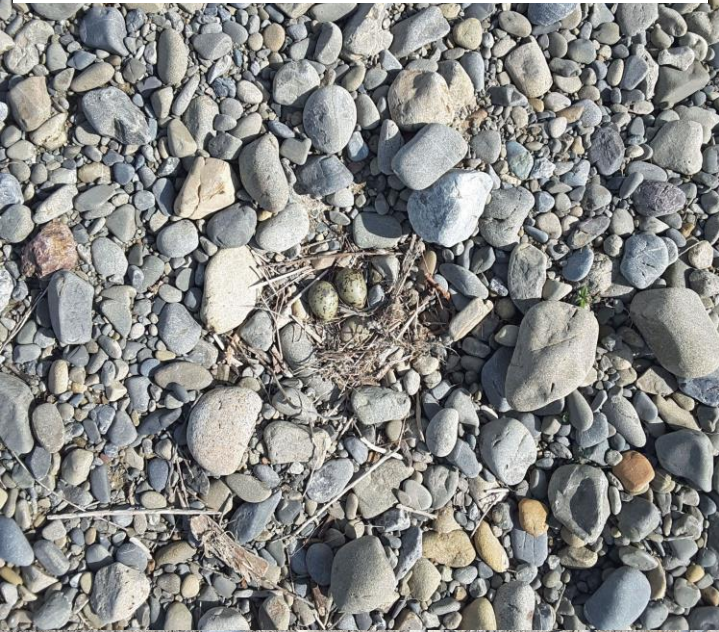
Poorly sorted coarse gravel – 85%

Optimal nesting substrate is weed-free, uncompacted, poorly sorted coarse gravel with scattered large pebbles at least 8cm in max dimension (but more often 10 – 14cm) – with space between them to fit a nest and bird where pebbles are \leq to egg size

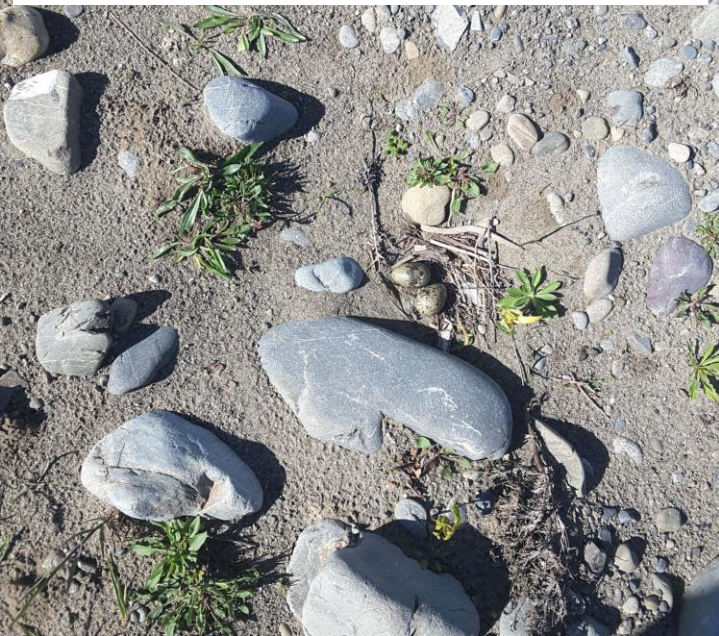
Sandy coarse gravel – 15%

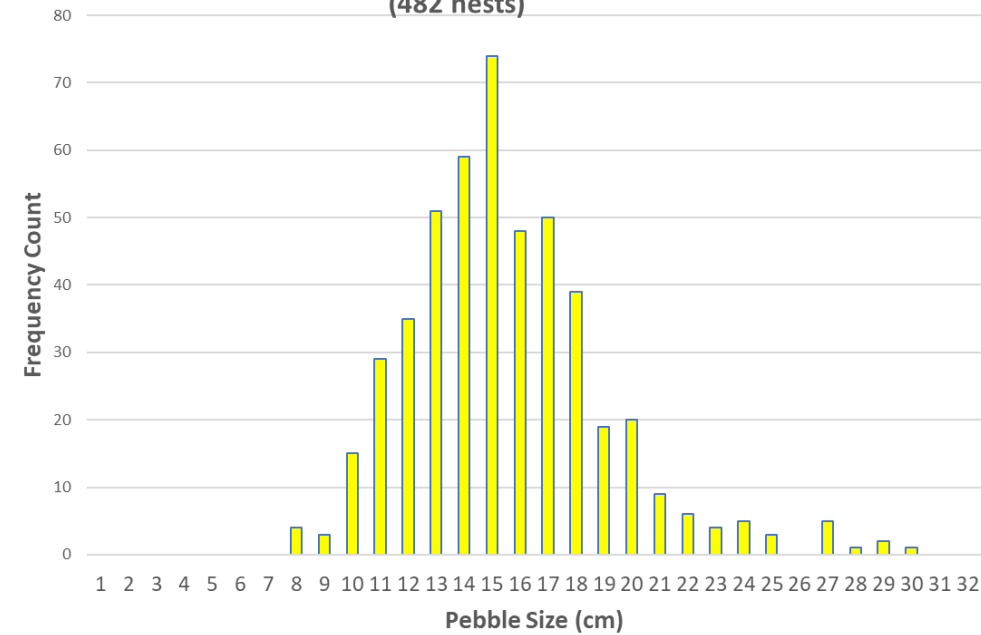
Maximum pebble size within 25cm of BBG Nest - Toppings 2019 (482 nests)

Optimal nesting substrate has scattered large pebbles generally at least 8cm in max dimension - but more often >12cm

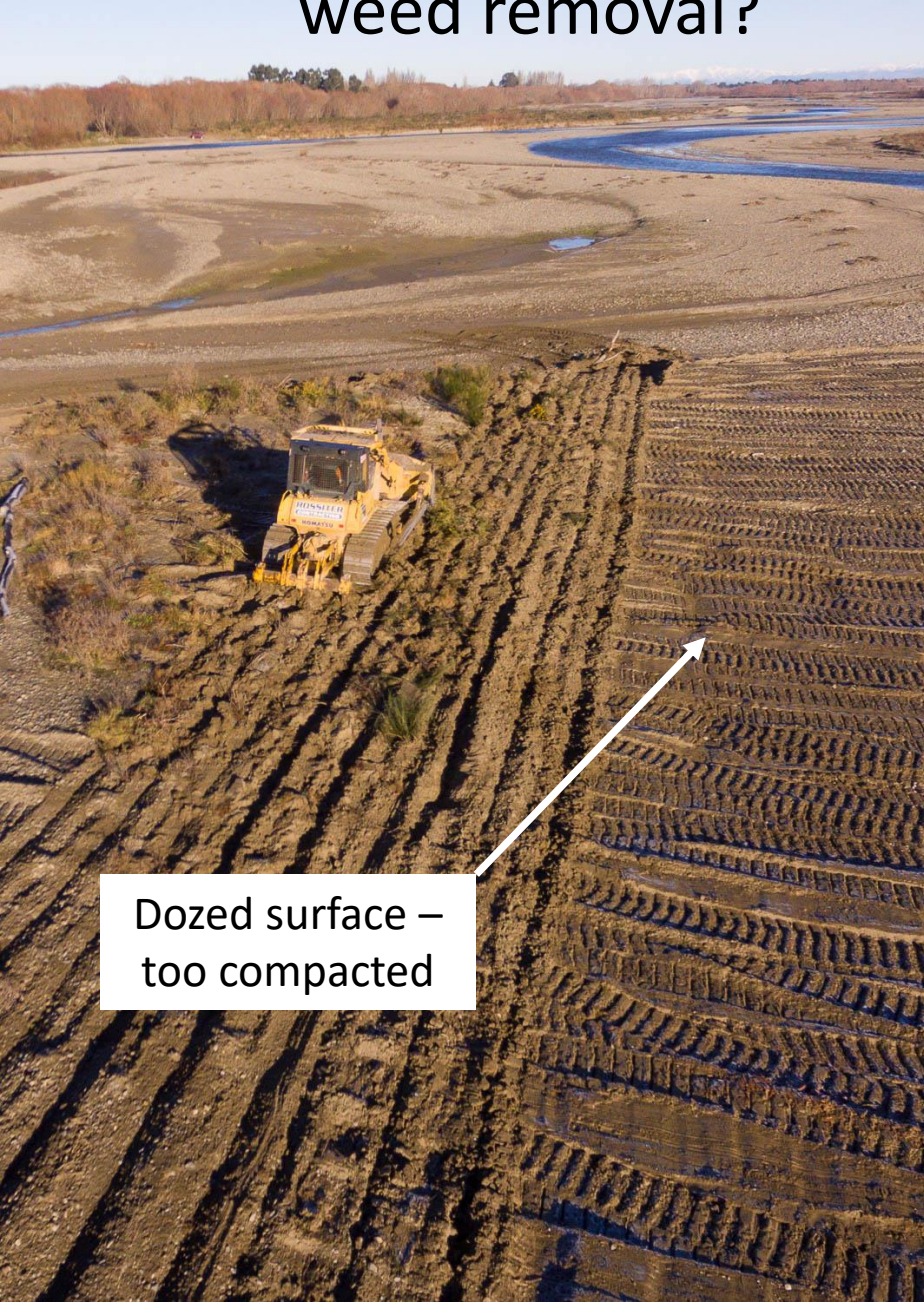
Dozed surface –
too compacted

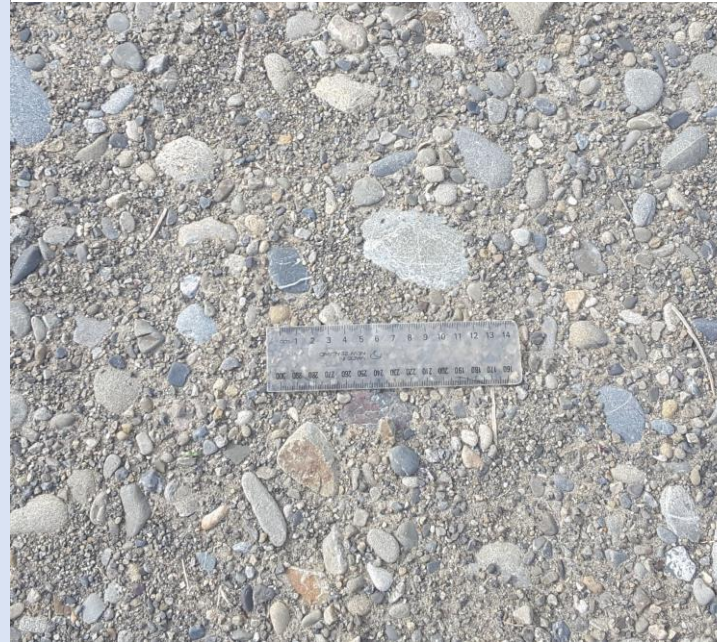
Graded surface – too compacted

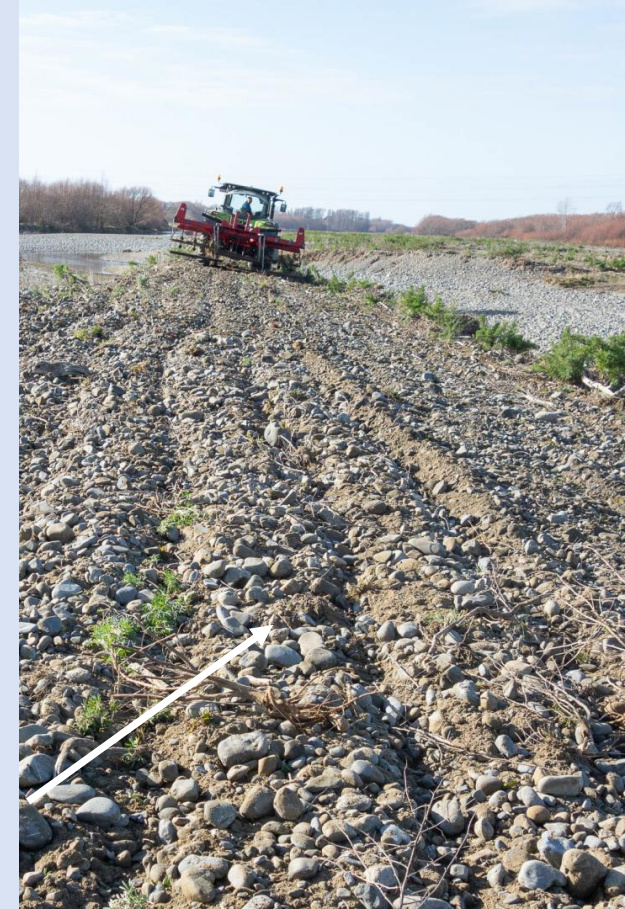
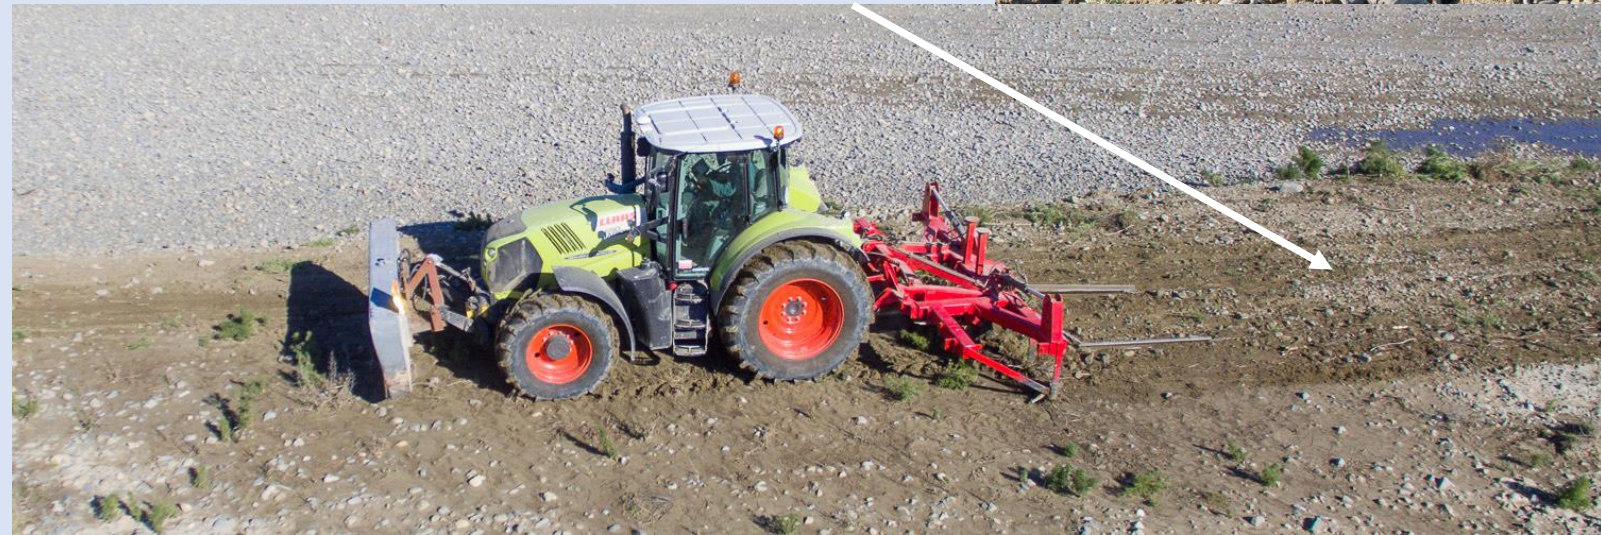
Tractor-mounted ripper (Cresslands Contracting) –
effectively clears lupin and doesn't compact
surfaces

- We need to clear islands that have the poorly sorted coarse gravel substrate that the birds prefer to nest on.
- Floods, especially smaller ones, while creating good nesting sites in some places, ruin them in others. Large rejuvenating floods are required to not only clear weeds, but to clear sand.
- Clearing of light weeds such as lupin must avoid compaction and minimize furrowing – which traps more sand.

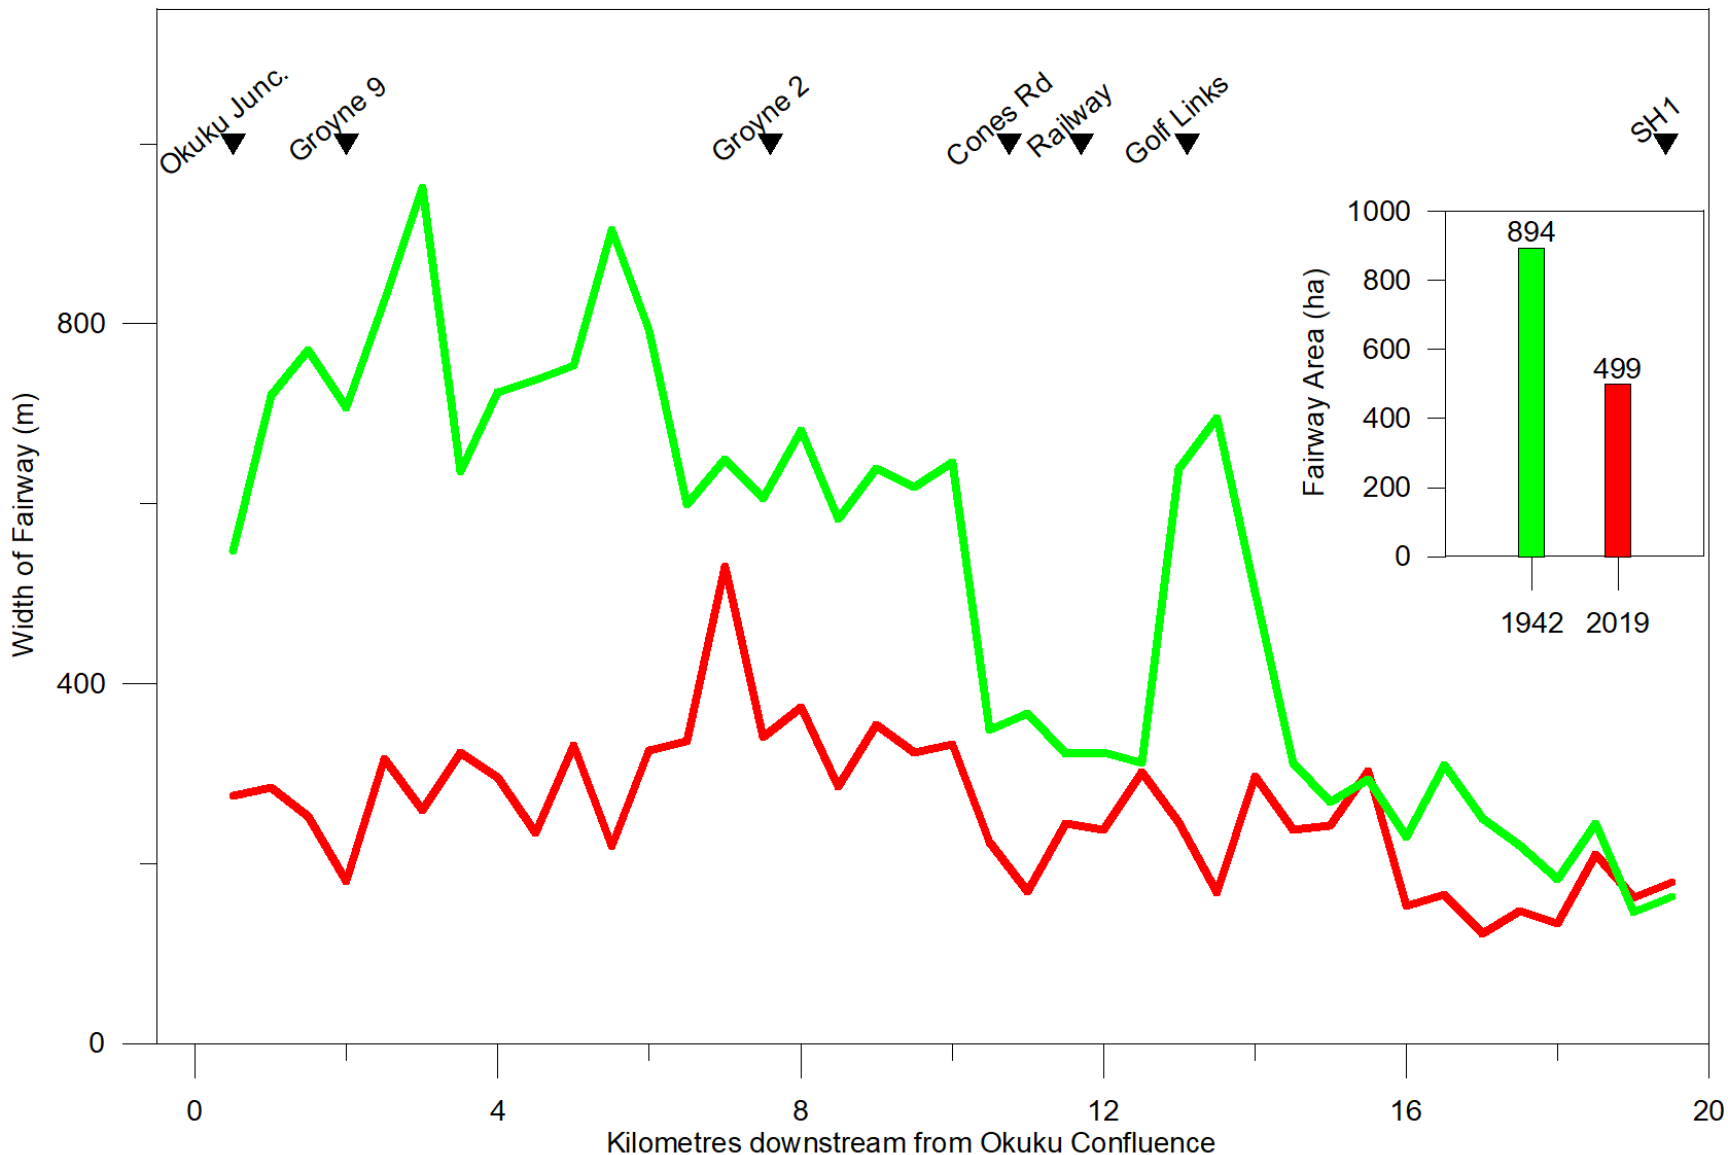
Width of Fairway, 0.5 km intervals downstream from Okuku Junction - 1942 and today

Area of fairway is little over half of what it was in 1942 – with a similar frequency and size of floods now and then. Fairway area has shrunk over the years – and is continuing to do so. In 50 years are we going to have a braided river?
