Kaunihera Taiao ki Waitaha | Canterbury Regional Council

Bird Island Annual Report

April 2026

Hakaterere Main Stem at SH1

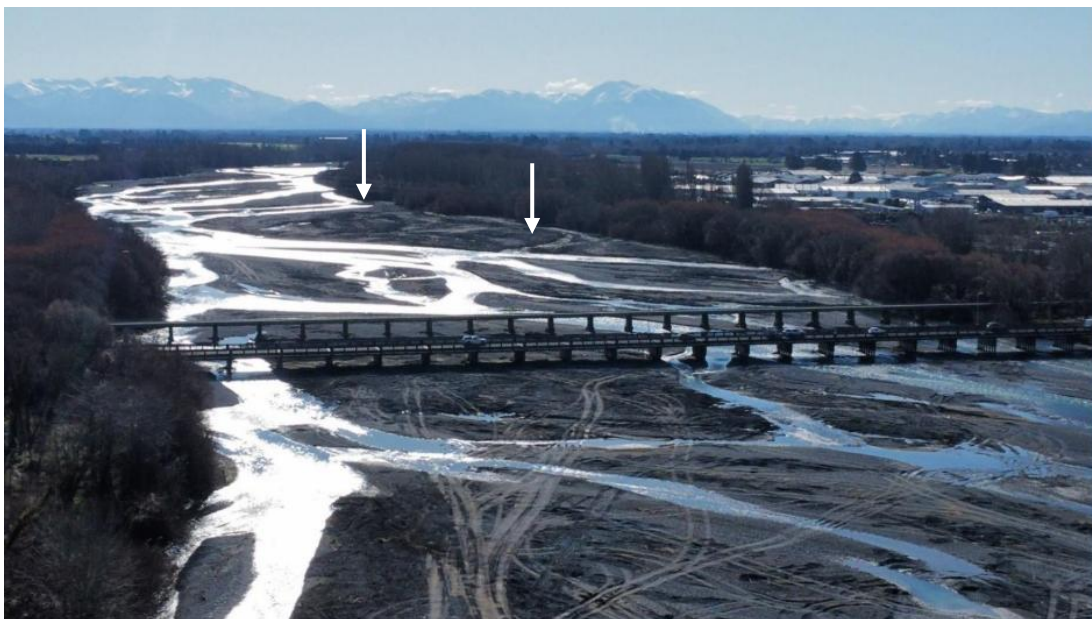
Figure 1: Drone image of Ashburton River, red arrows indicating upstream and downstream extent of the diversion.

A pre-works inspection was undertaken in April 2025, representatives from Arowhenua Rūnanga were in attendance. The goal of this inspection was to assess the suitability of the site for enhancement work. A split-flow diversion was deemed an appropriate method for deterring predators at this site. It was determined that sufficient flow could be supplied to both the existing and existing dry channel by Dan Meehan, area engineer for central canterbury. Works were carried out on the 28th of August 2025, under the supervision of Mark Faichnie, area supervisor for central on behalf of Dan Meehan. Desktop inspections, environmental planning and works supervision was carried out by ECan staff. Physical works were carried out by Ashburton Contracting Ltd (ACL) representatives.

A pre-start walk over with ACL was completed before works started to identify key risks and confirm methodology. Work began to excavate the dry channel, working from the downstream end up. The diversion followed COP process, the water was let into the deepened braid as a last step. This work was carried out using a 30t excavator.

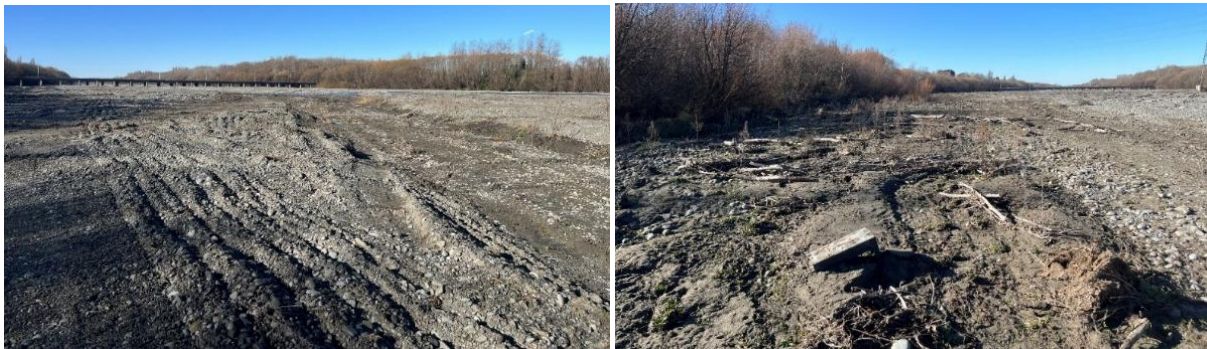
Figure 2: Before looking downstream toward the SH1 Bridge, taken 27th August.

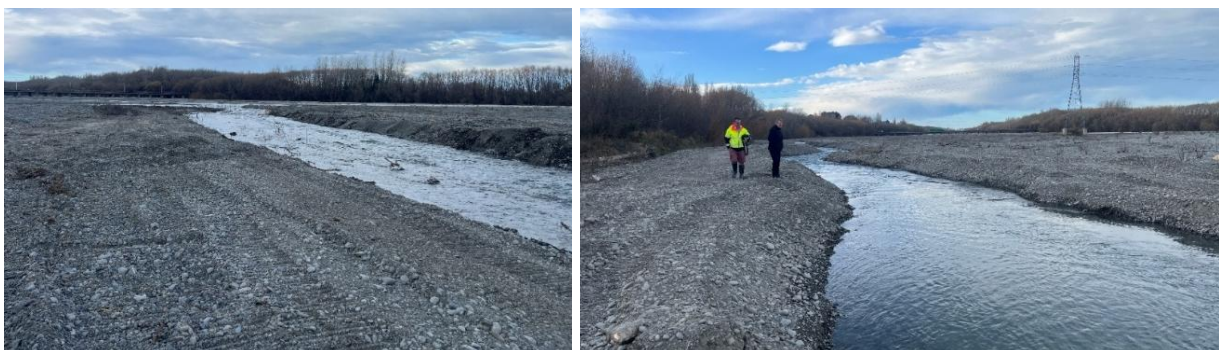
Figure 3: After diversion works are completed, taken 29th of August.

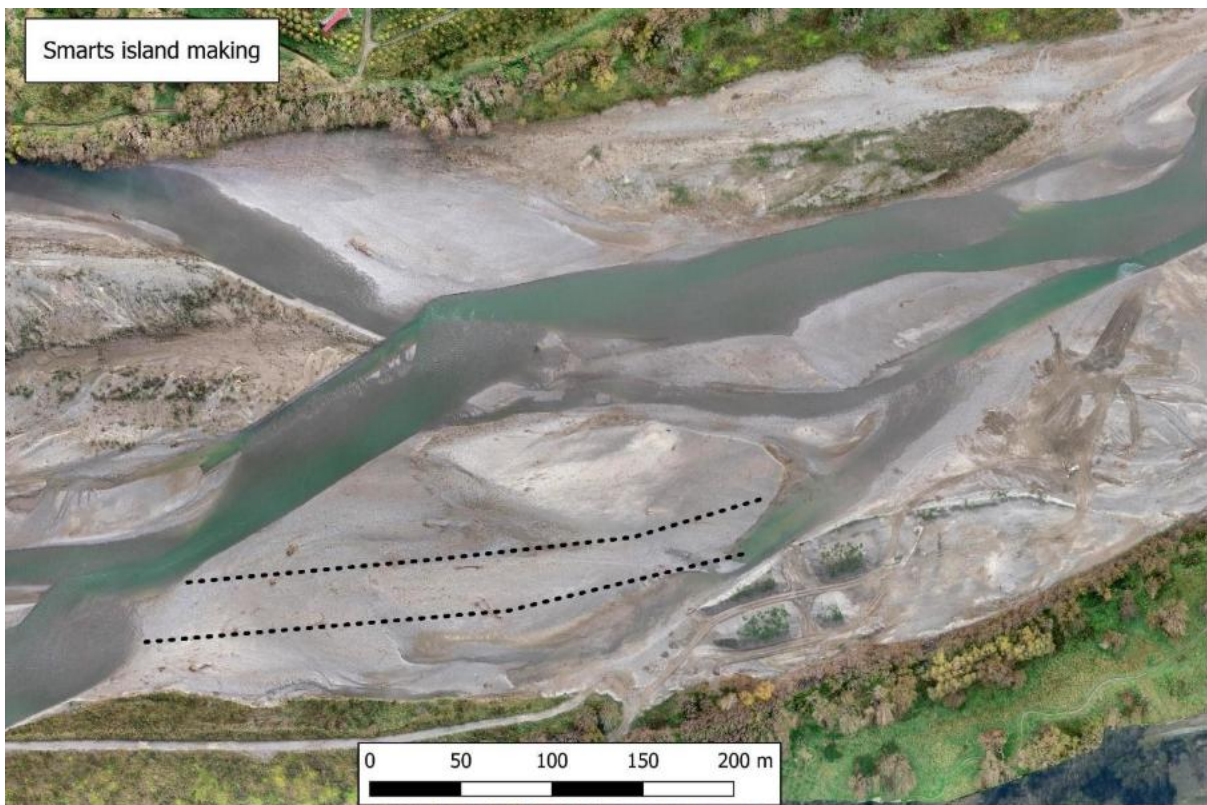
The site at Smarts Road has been a productive breeding site for Tarapirohe, Poaka, Ngutu parore and other species for several years. This work was carried out by working with a local gravel extractor, which has been an approach used in previous years. The Ashley Rivercare Group was also heavily involved with the identification of habitat and continue to be an important collaborator throughout the Rakahuri. A split flow diversion was used to improve flow on the true right bank of the island to reduce predator pressure on potential nesting birds.

Figure 4: Proposed Island at Smarts rd, drone imagery taken by Grant Davey

Following site selection meetings and desktop inspections, this site was determined to be a candidate for island enhancement. Using a 20t excavator, a dry braid was dug out. Some of the material was taken out of the riverbed under the gravel abstractors existing take. Greg Stanley and Grant Davey were on site for the pre-start walk-over to re-iterate the methodology and site sensitivities. Grant Davies remained on site for the works to maintain an eye on some ngutu pare and other bird species active in the area. The final step of the diversion was to make the upstream cut to allow water down the braid. This was completed after a phone conversation with Greg Stanley.

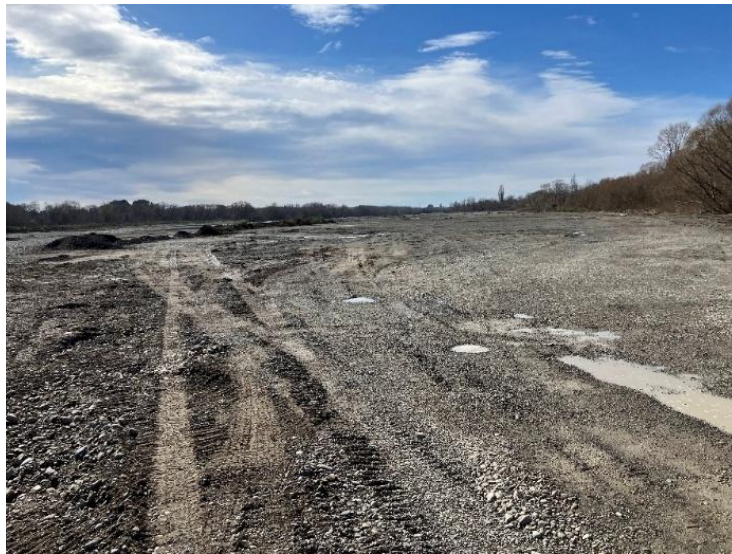
Figure 5: Before taken on the 1st of September 2025.

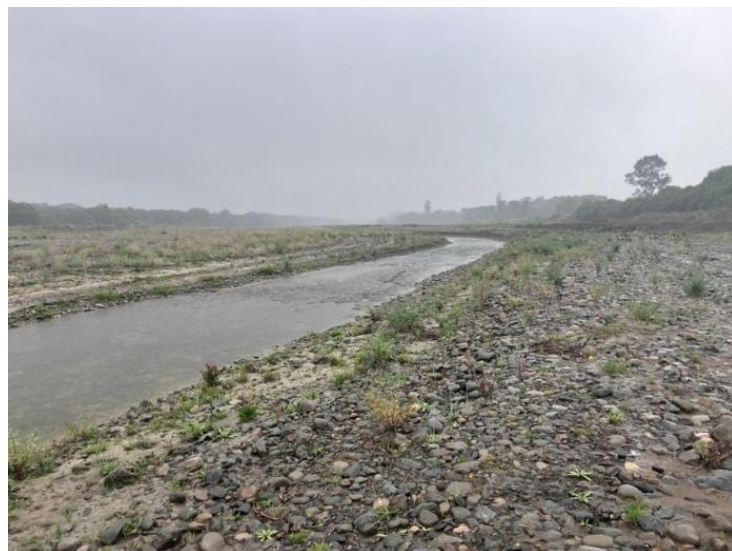
Figure 6: After diversion works on the 16th of January 2026.
